CHRISTCHURCH CATHEDRAL
DAMAGE ASSESSMENT REPORT
PREPARED FOR
CHURCH PROPERTY TRUSTEES
14 MARCH 2016

EXECUTIVE SUMMARY

Holmes Consulting Group LP has been engaged by Church Property Trustees to complete a visual post earthquake damage assessment of the Christchurch Anglican Cathedral.

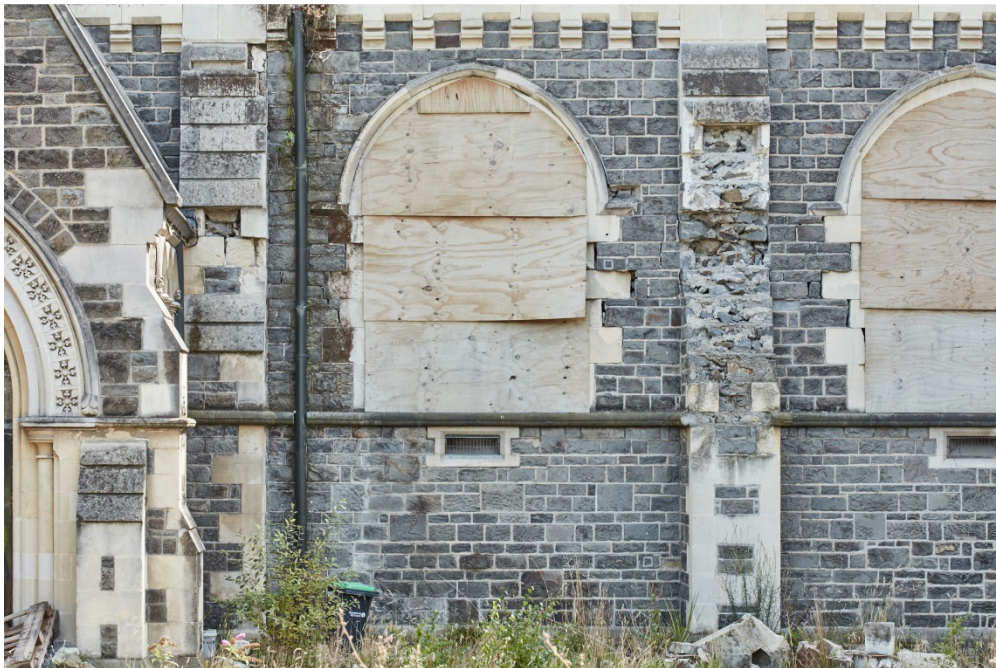
1. Increase of earthquake damage to the badly damaged south aisle walls. Additional spalling of masonry piers was observed and ashlar cracking damage has increased (refer Figures 1 & 2)

Figure 1: Exterior of south aisle wall, March 4th 2016

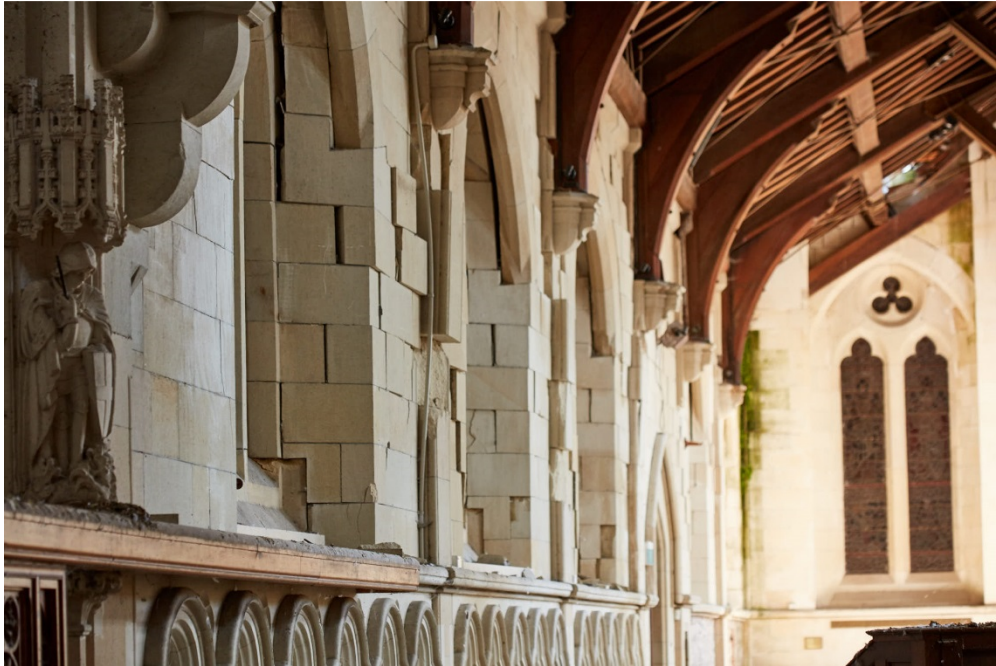
Figure 2: Interior of south aisle wall, March 4th 2016

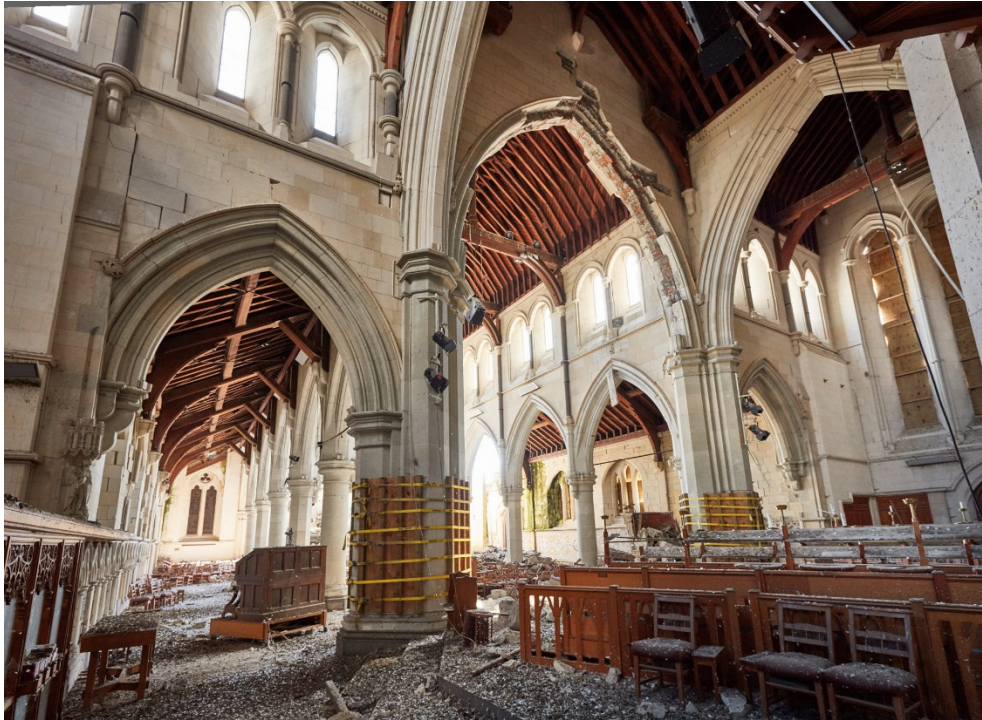
2. Damage to the transept arches has noticeably increased. Additional spalling of ashlar has occurred (refer Figure 3 below).
3. Cracking to the north wall of the apse and related buttress have noticeably increased. Figures 4 and 5 below illustrate the state of damage to the effected building elements.

Figure 3: Interior of west transept arch, March 4th 2016

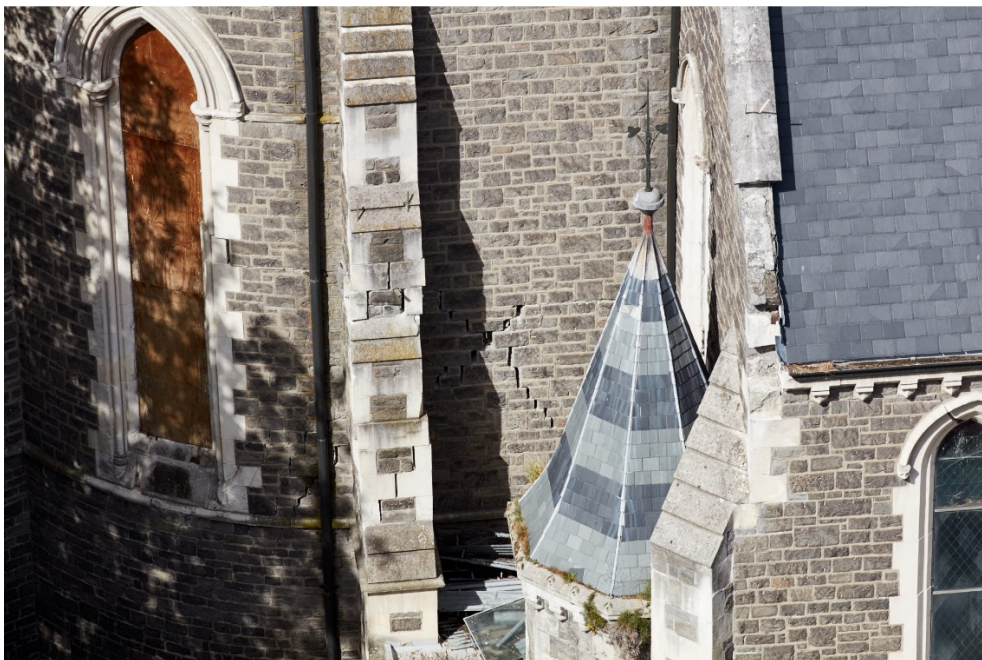
Figure 4: Exterior of apse north wall, March 4th 2016

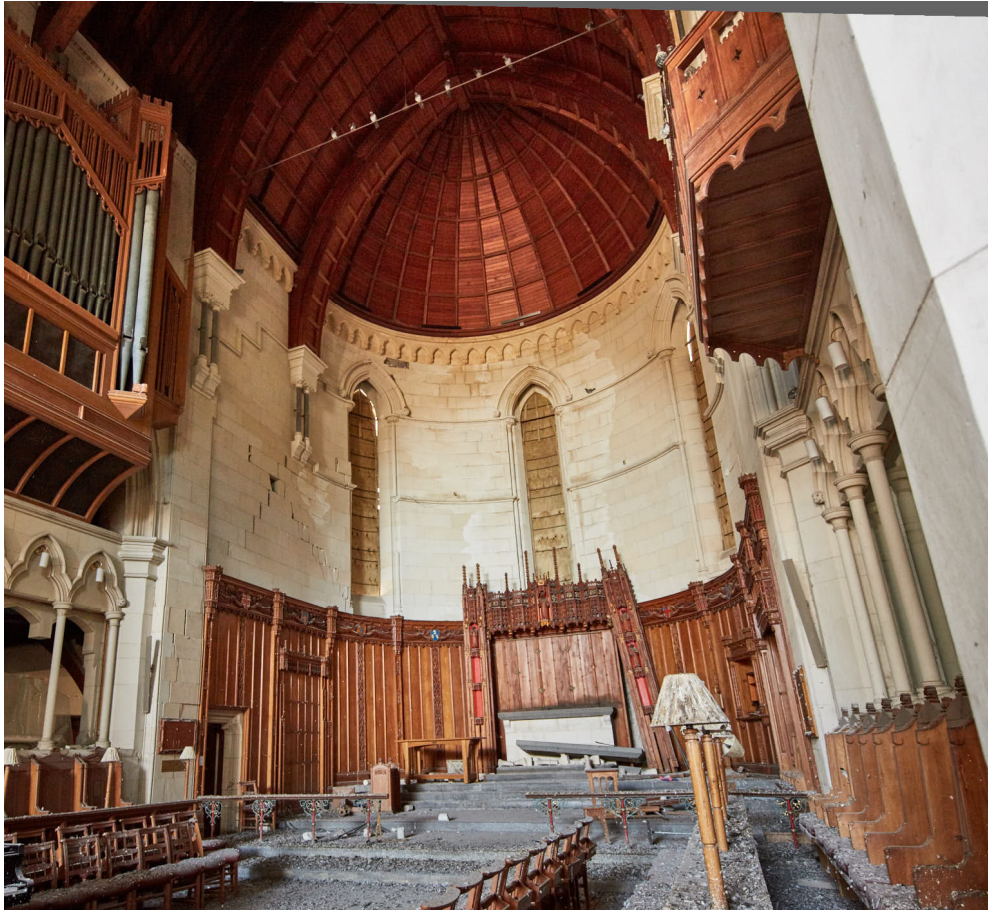
Figure 5: Interior of apse north wall, March 4th 2016
