CHRISTCHURCH CATHEDRAL
DAMAGE ASSESSMENT REPORT
PREPARED FOR
CHURCH PROPERTY TRUSTEES
FEBRUARY 17TH, 2016

EXECUTIVE SUMMARY

Holmes Consulting Group has been engaged by Church Property Trustees to complete a further review of the Cathedral. The purpose of the review has been to update the damage assessment of the building following the February 14th 2016 aftershock.

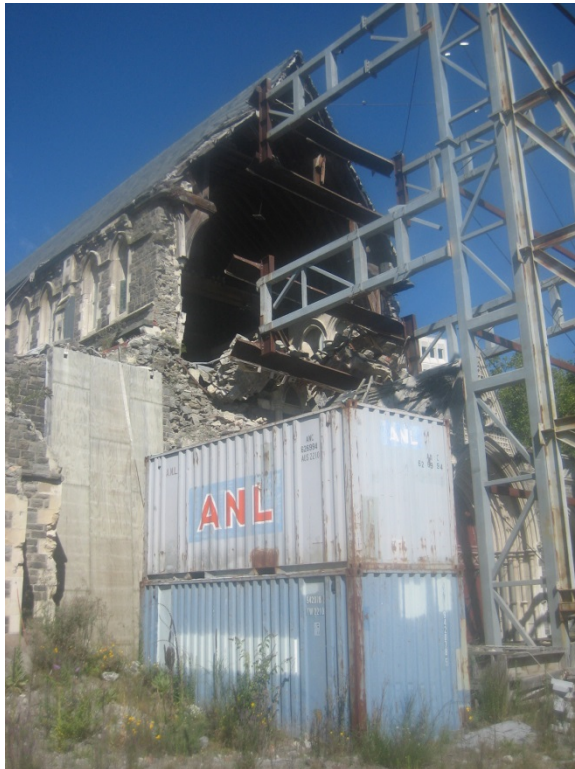
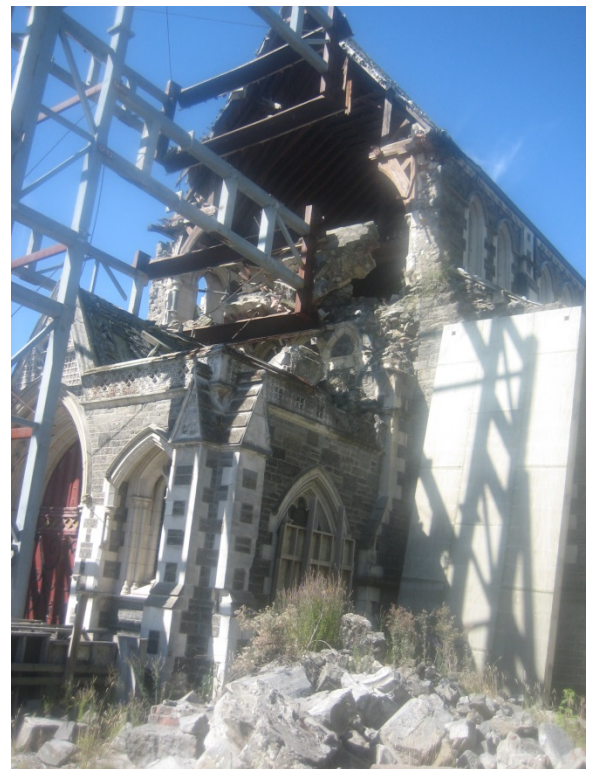
1. Additional loss of material from the west wall with consequential additional damage to the west porch below. (refer Figure 1 below)

Figure 1: West wall, February 15th 2016

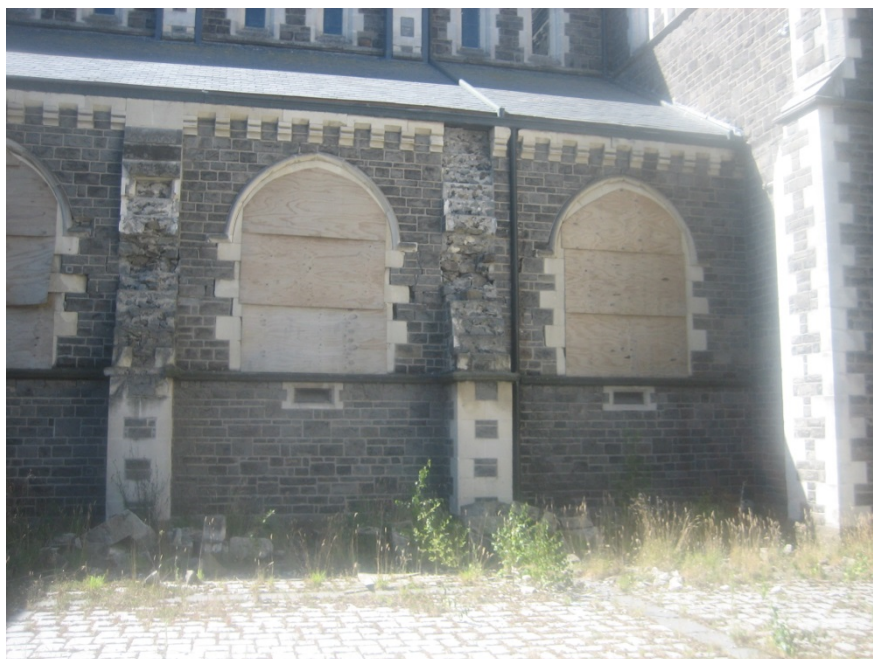
2. Significant increase of earthquake damage to the badly damaged south aisle walls. Crack widths in masonry piers were observed to have significantly increased and additional spalling of ashlar has occurred. (refer Figures 2 & 3)

Figure 2: Exterior of south aisle wall, February 15th 2016

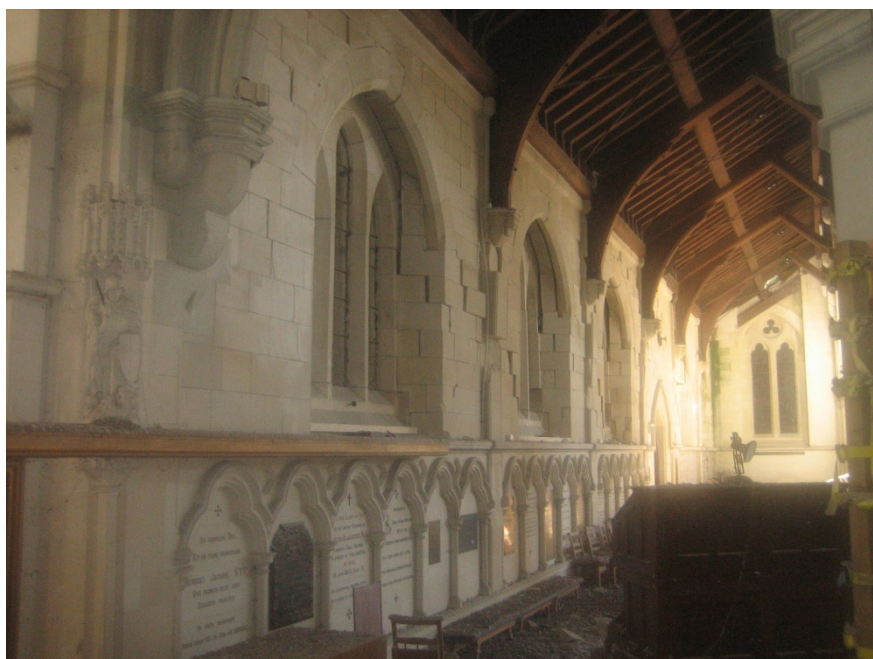
Figure 3: Interior of south aisle wall, February 15th 2016

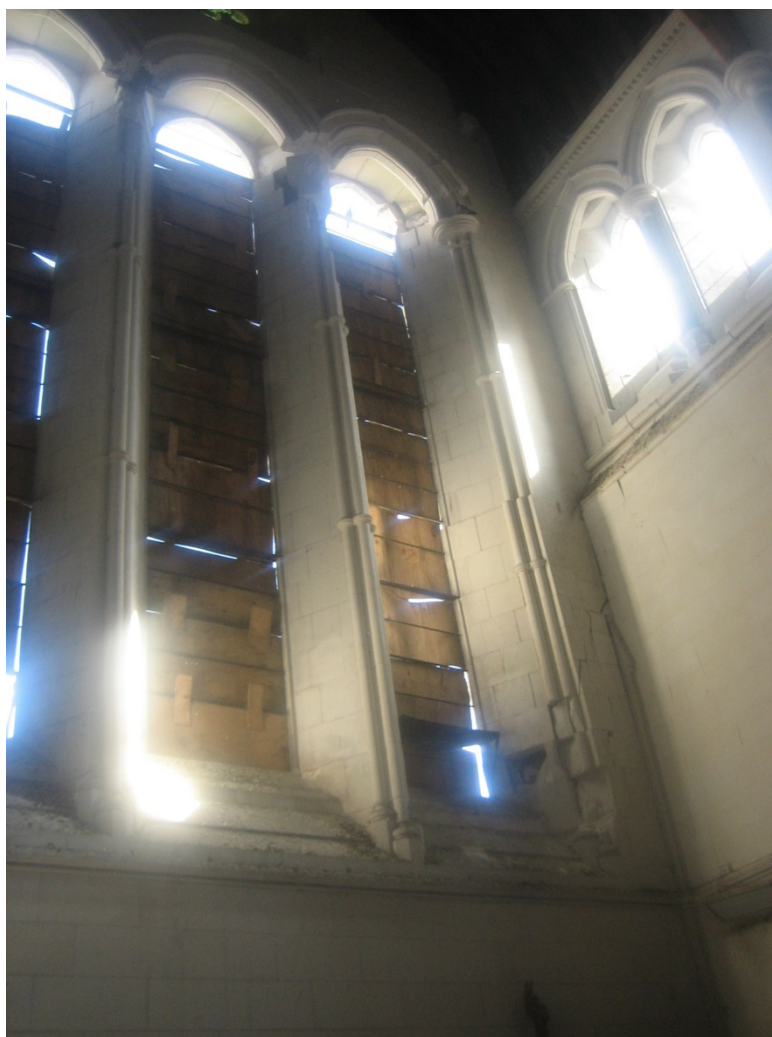
3. Offsets previously observed in the south transept gable have significantly increased with consequential additional damage to ashlar (refer Figure 4). Additional damage to the north transept gable was less significant.

Figure 4: Interior of transept south gable, February 15th 2016

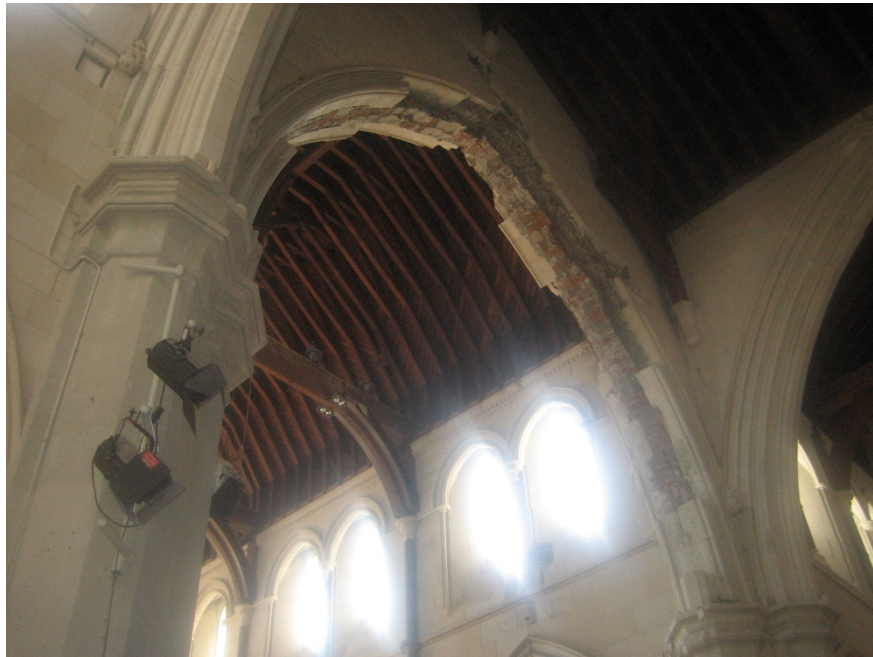
4. Damage to the transept arches has noticeably increased. Significant quantities of new rubble were observed to have fallen onto the floor of the crossing and this has caused additional damage to the pulpit. (refer Figures 5 & 6).

Figure 5: Interior of west transept arch, February 15th 2016

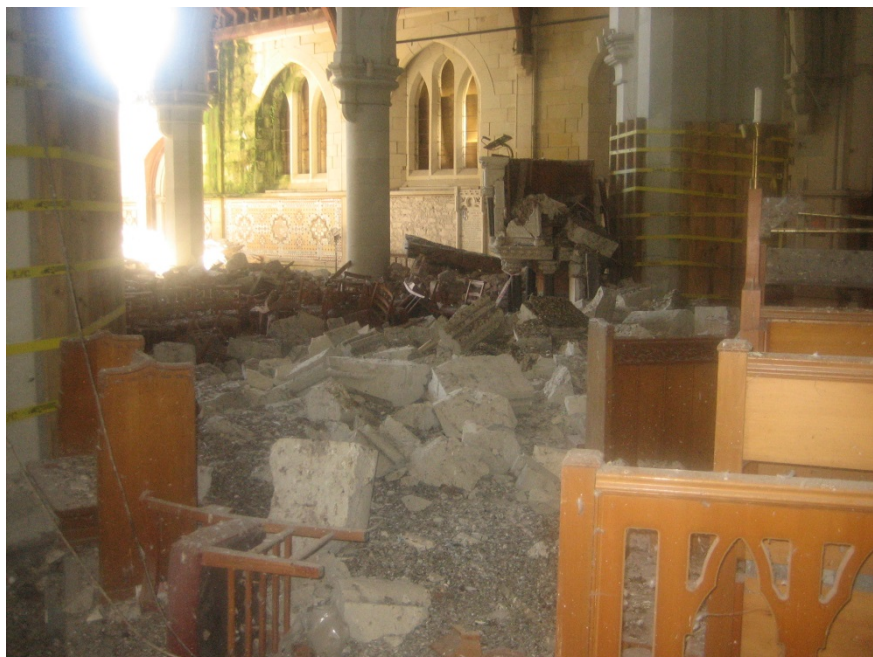
Figure 6: New fallen debris on the floor of the crossing, February 15th 2016

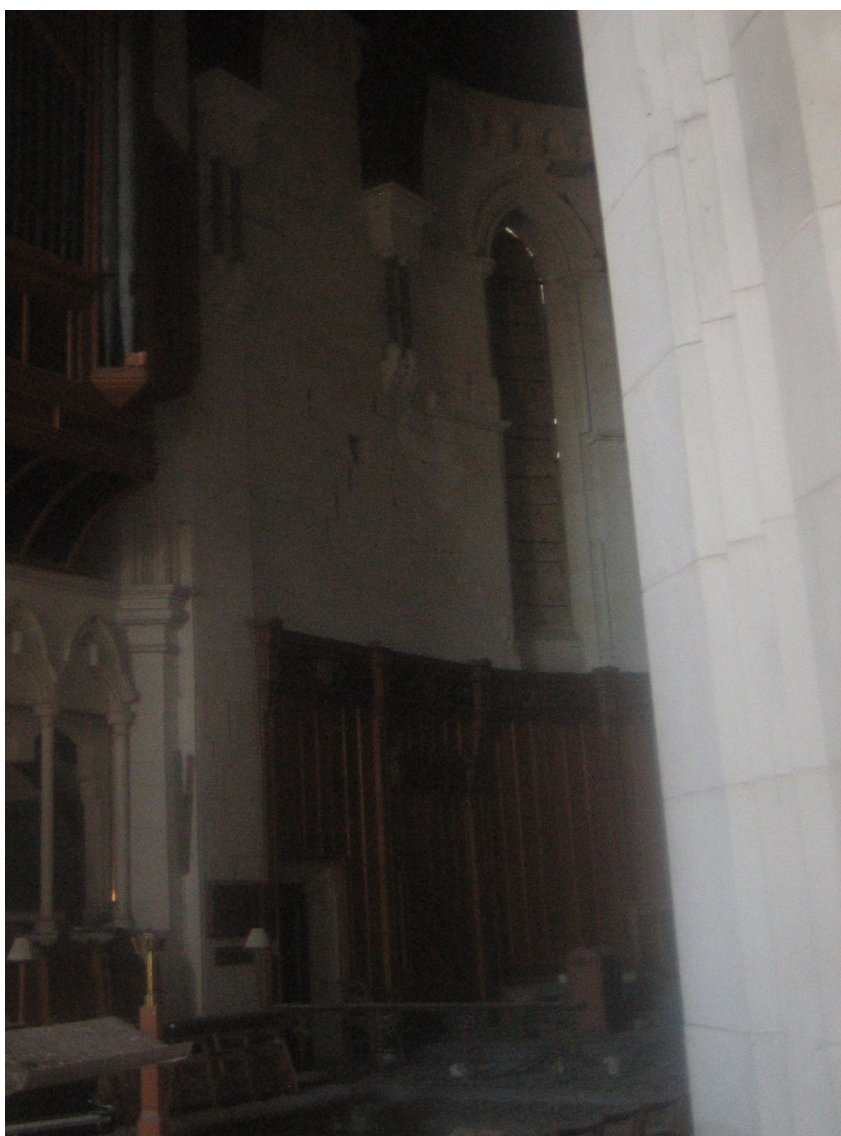
5. Cracking to the north and south walls of the apse have noticeable increased. Figure 7 below illustrates the state of damage in the north apse wall.

Figure 7: Interior of apse north wall, February 15th 2016
