**REPORT ON FACILITATED DISCUSSIONS WITH ENGINEERS FOR CHURCH
PROPERTY TRUSTEES AND THE GREAT CHRISTCHURCH BUILDINGS TRUST ON
ENGINEERING OPTIONS FOR REPAIR, RESTORATION OR REPLACEMENT OF
CHRISTCHURCH CATHEDRAL**

Miriam R Dean:	Facilitator
John Hare:	Holmes Consulting Group LP
Adam Thornton:	Dunning Thornton Consultants Ltd

NOVEMBER 2015

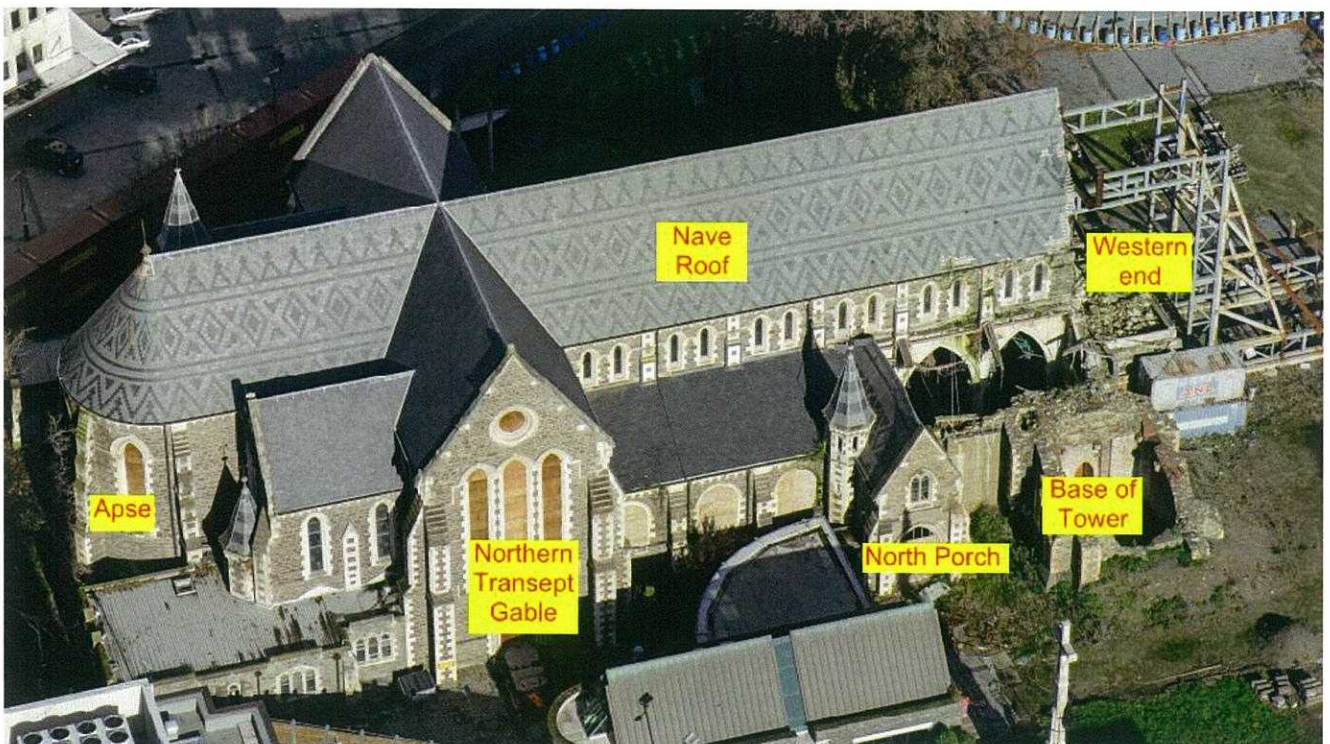
Figure 2: Current view from the north

Portions of the tower and west wall have collapsed or have been substantially demolished. Other parts are damaged to varying degrees as summarised below. In particular, the earthquake motion caused relative movement between the upper part of the building and the foundations, resulting in a zone of damage that is mostly concentrated in the walls between the eaves and sills. The damage typically consists of lines of cracking, the crack widths varying from a few millimetres to about 60mm. There are some areas of residual offset.

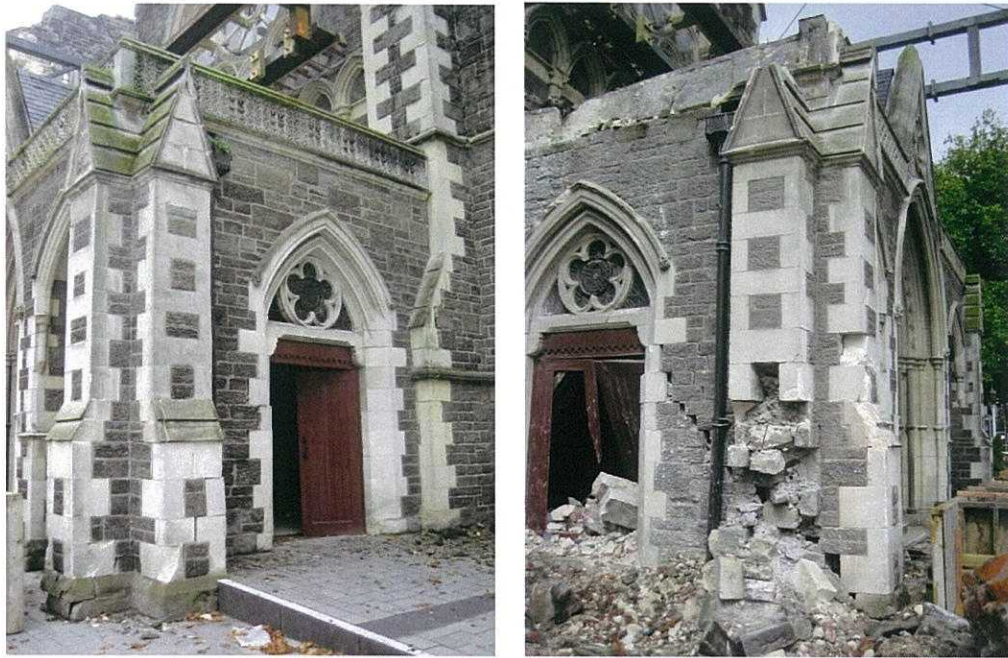
The west porch is permanently offset from the west wall by between 20mm and 30mm. There is moderate damage to the south and west walls and significant damage to the north wall. Damage to this last wall includes parapet collapse and significant spalling (loss of small pieces of masonry) of the north-west buttress. The north portion of the roof collapsed as a result of falling tower debris.

Figure 4: Damage observed to the west porch

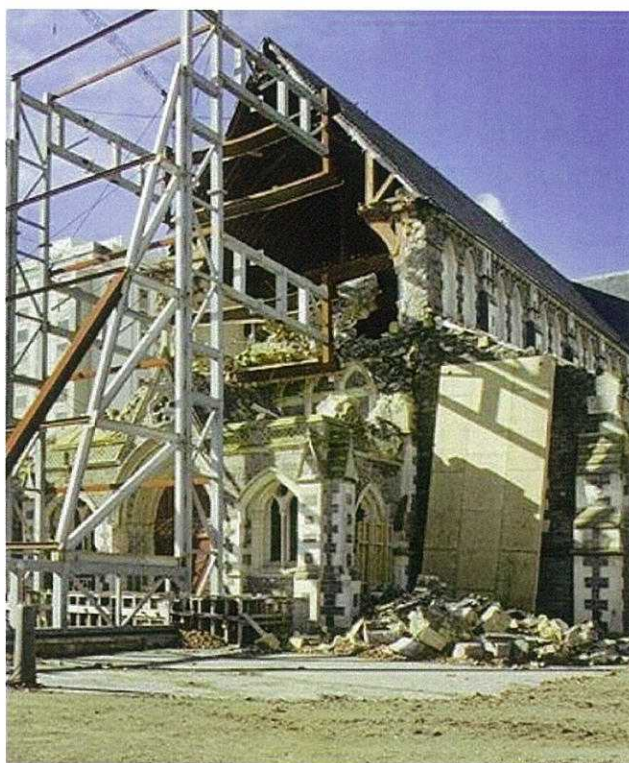
The west wall is significantly damaged. The top portion, including the rose window and buttresses, has totally collapsed. The remainder is distorted. The end walls to the side aisles are less damaged. The parapet capping stones were removed in 2011, and plywood panels in front of these walls act as protective screens to the windows. The concrete shear walls (inserted in 1999) were probably effective in preventing further damage.

Figure 5: Damage observed to the western end

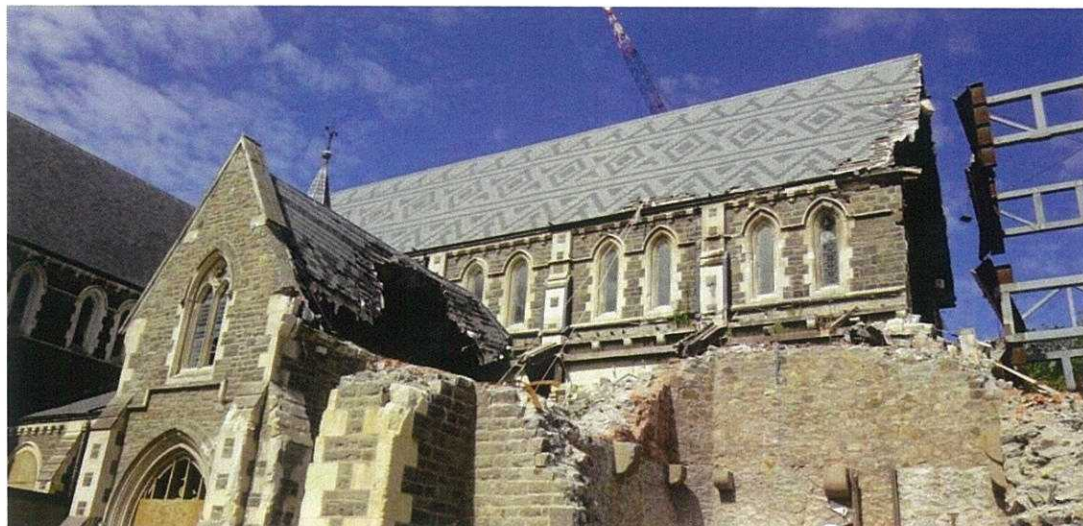
The north aisle roof has collapsed at the western end as a result of falling tower debris. The south aisle roof bracing has stretched and is visibly sagging. A bracing truss connection has been lost at the junction with the south porch.

There is a relatively small area of damage to the main nave roof where the west wall collapsed. There is little visible damage to the original roof cladding and structure in areas away from the tower and west end collapse.

Figure 6: Damage observed to the north aisle roof

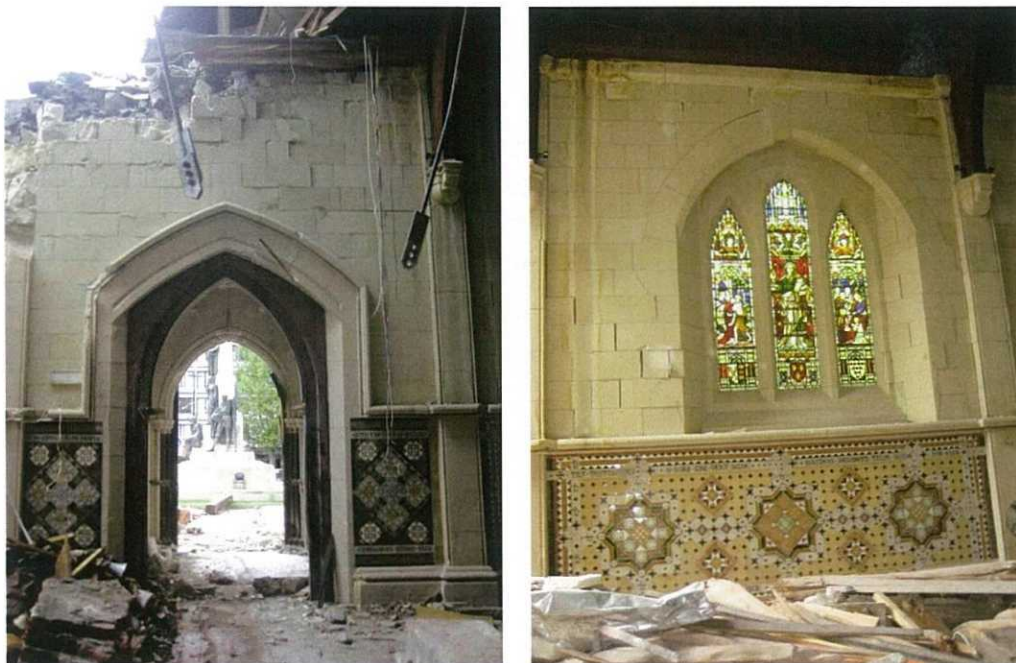
The north wall has cracking through the wall piers and buttresses of between 5mm and 15mm.

Figure 7: Damage observed to the north aisle wall

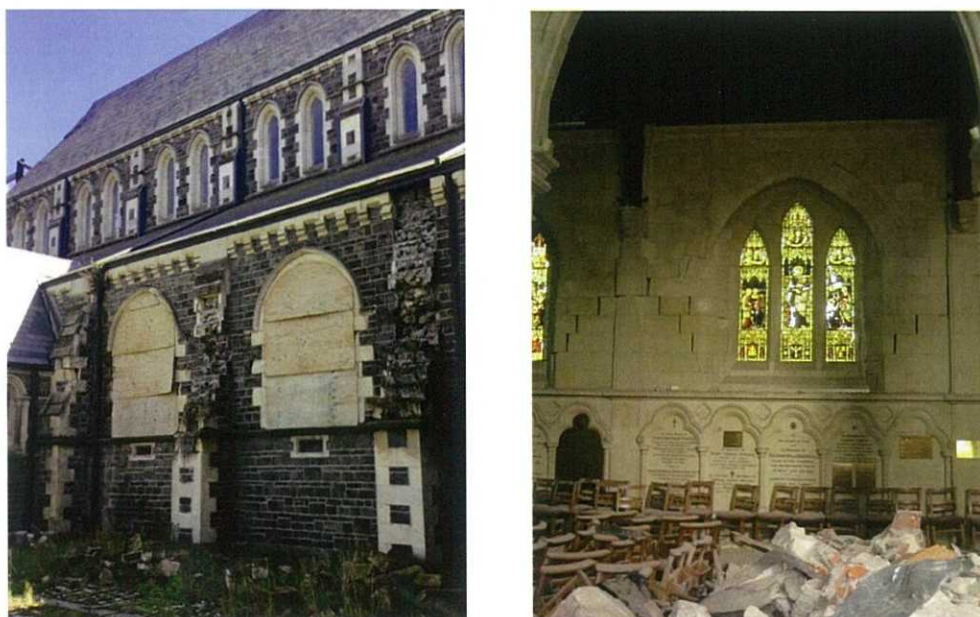
South wall piers and buttresses show damage similar to that observed in the north wall. However, the cracks are significantly wider (10mm to 50mm). Wider cracks in the buttresses indicate increased degradation of the walls. The projecting faces of two buttresses were removed from the face of the wall for safety. Some glass damage has occurred as a result of the structural deformations.

Figure 8: Damage observed to the south aisle wall

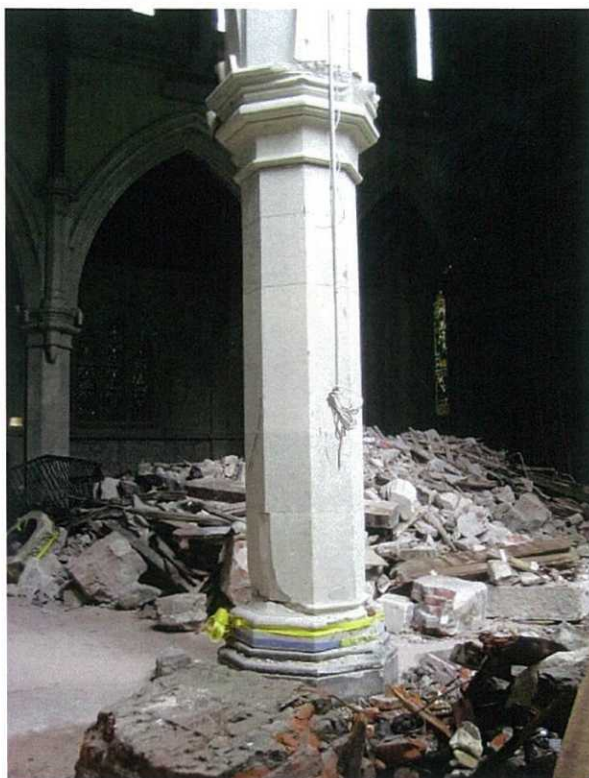
High-level clerestory walls in the north-west corner have an outward lean as a result of the tower collapse. There is minor to moderate cracking in other areas of the north clerestory walls. No significant structural damage appears to have occurred to the south clerestory walls. Nave columns and arches have varying degrees of damage and dislocation, reflecting movement in the clerestory walls above.

Figure 9: Damage observed to an arch and column within the nave

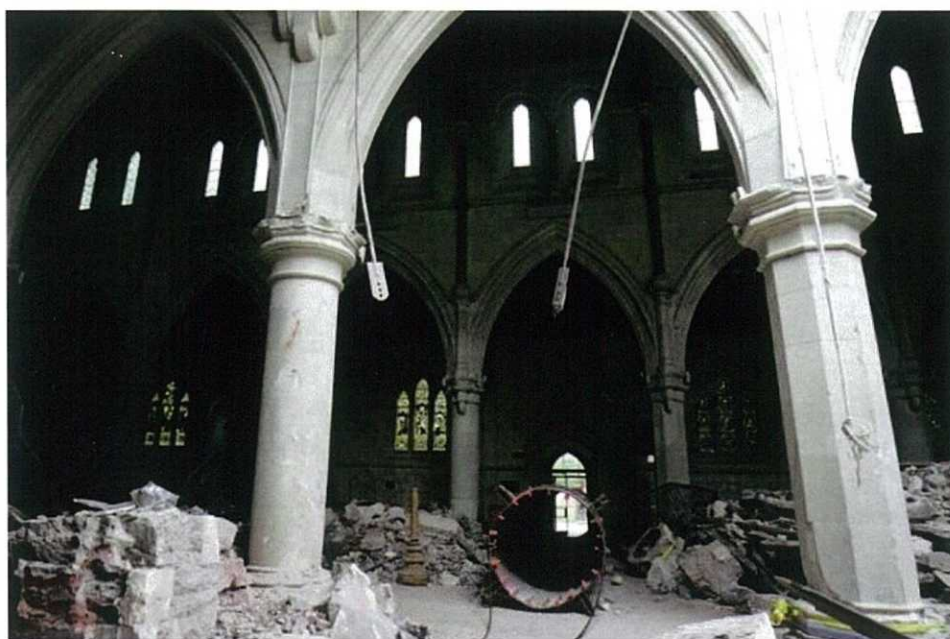
Figure 10: Tower debris within the nave

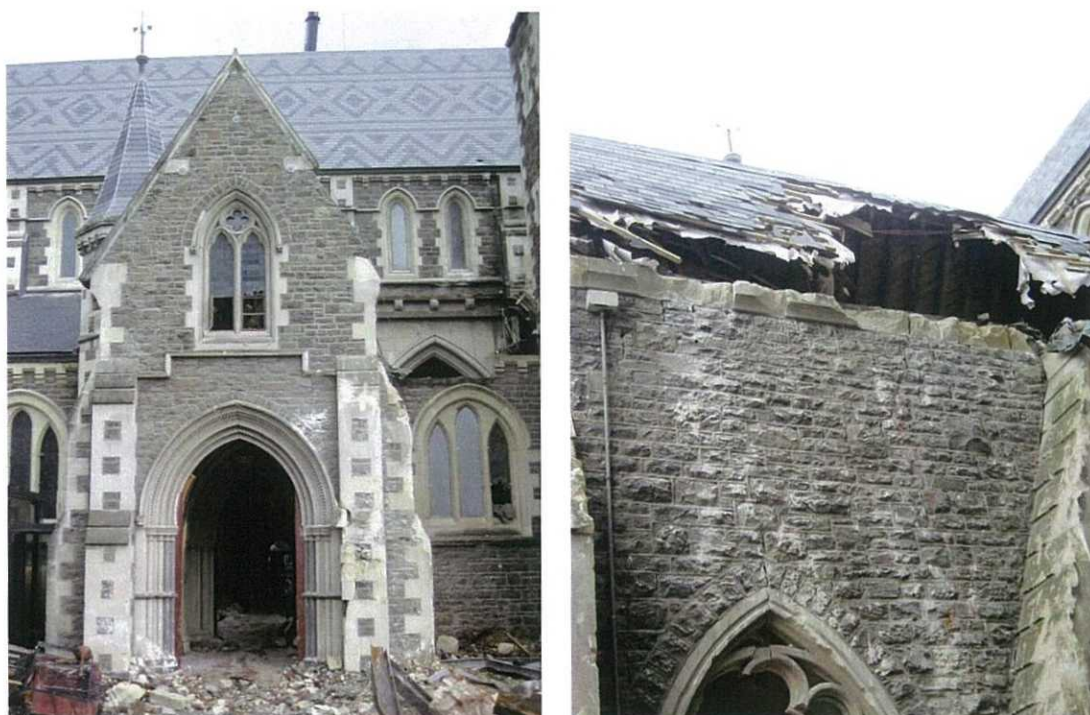
The west wall and buttresses of the north porch are damaged from falling tower debris. Stone elements that make up the north gable end have surface damage. Falling tower debris has caused much of the west side of the north porch roof to collapse. Cracks can be observed in the ceiling.

Figure 11: Damage observed to the north porch

A significant amount of tower debris has fallen through the north porch roof and remains on the existing attic floor. The north turret appears to be generally in good condition but with some glass breakage. There is minor cracking (1mm to 3mm) in the supporting stairwell walls.

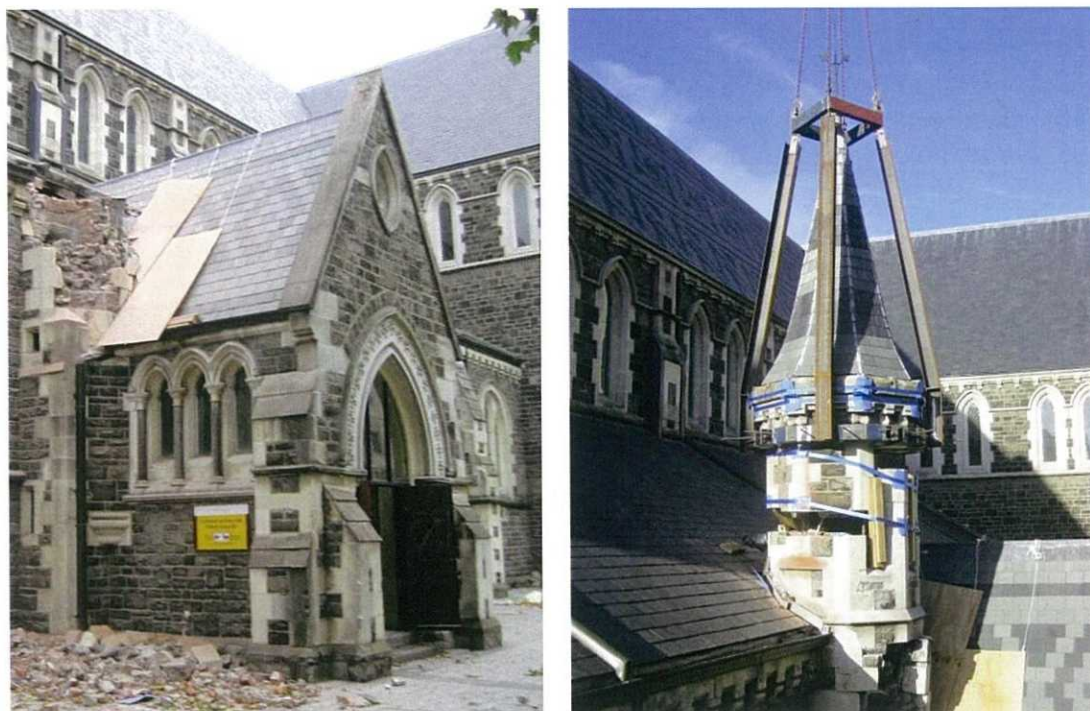
The south porch is generally in good condition except for severe damage to the stairwell wall that supports the south turret. The turret was removed to the grassed area to the south of the cathedral in early March 2011.

Figure 12: Damage observed to the south porch, and relocation of the south turret

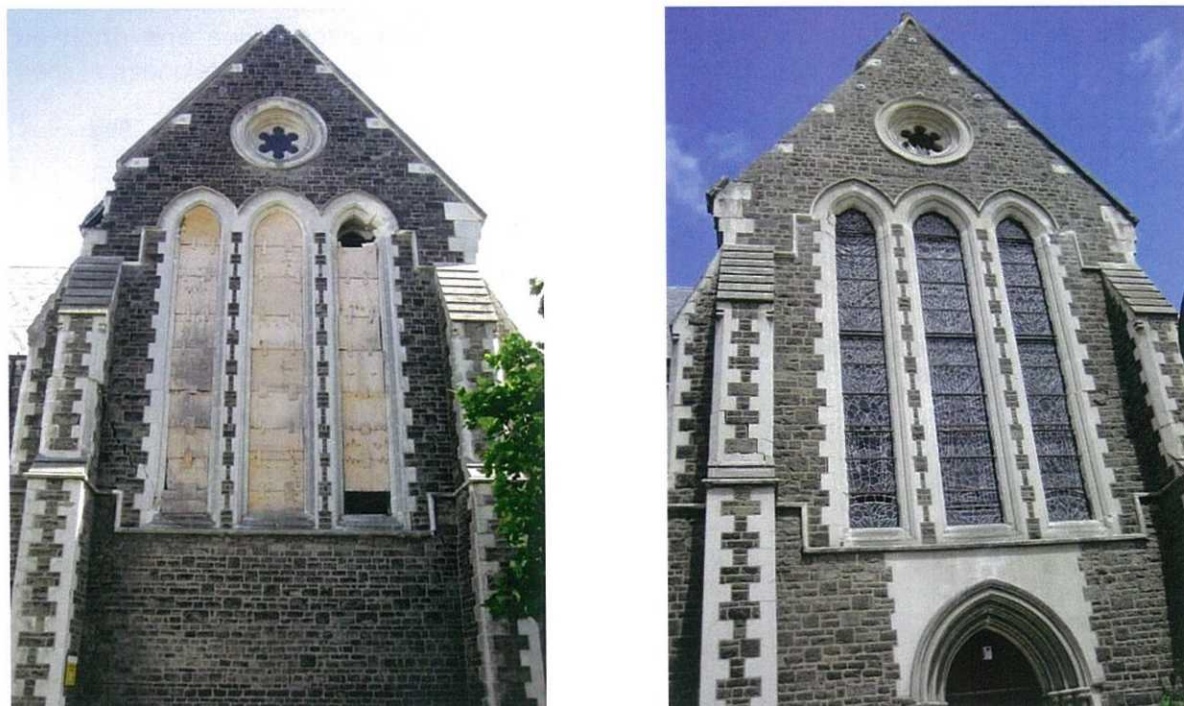
The north and south transept walls have cracking and dislocation. The upper regions have a residual horizontal offset of between 30mm and 60mm for the north and south walls respectively. The north and south transept wall gables have a perceptible lean outwards.

Figure 13: Northern transept gable wall and southern transept gable wall damage

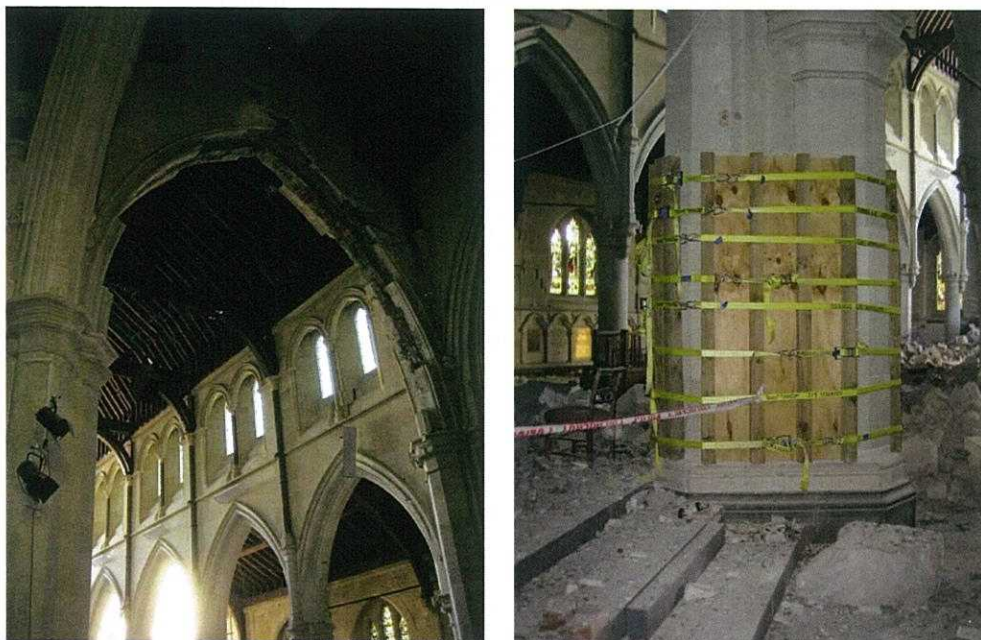
The central transept area has suffered damage from transverse motions. There is severe damage to the west arch where it forms the junction to the nave. Immediately after the earthquake, temporary strapping was added to the damaged masonry columns that support the transept arches.

Figure 14: Damage observed in the transept (from 2012)

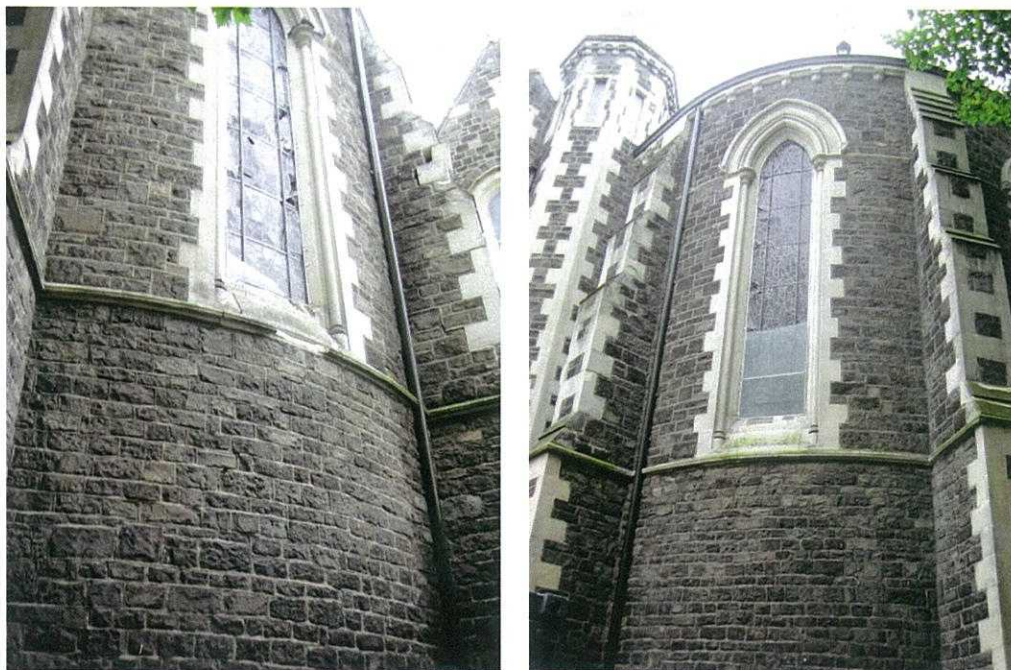
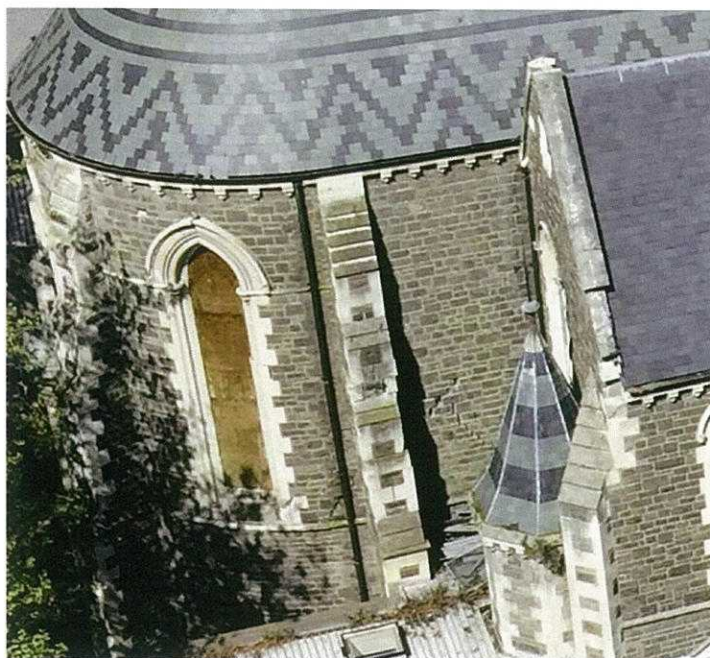
The north and south apse walls have cracking of about 50mm and 20mm respectively. There is associated glass damage. The central east wall is less damaged.

Figure 15: Damage observed to the apse

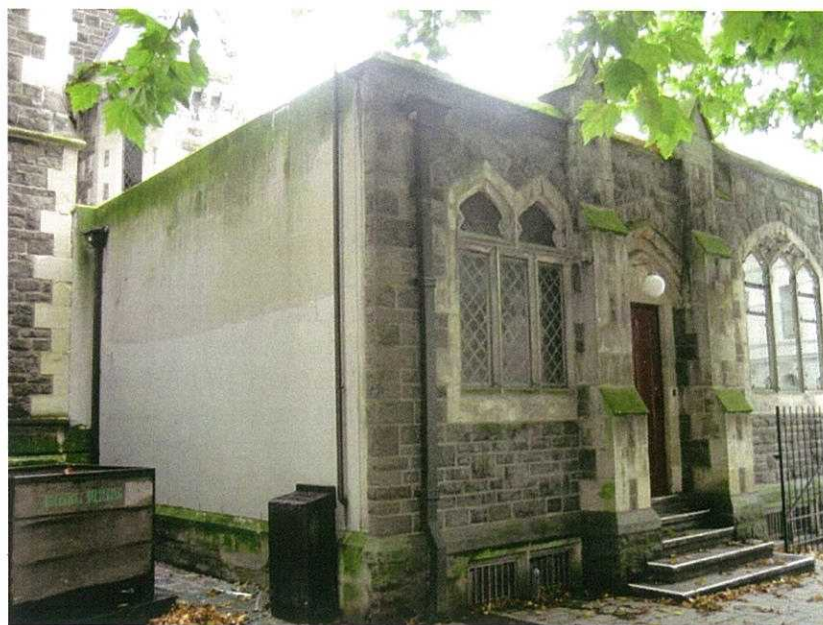
The north and east walls, believed to be of reinforced concrete, are largely undamaged. The south wall, believed to be a plastered concrete block infill wall, has minor cracking. The original unreinforced masonry walls have cracking as well as permanent offset of about 50mm, much like that to the apse.

Figure 16: Damage observed to the clergy vestry

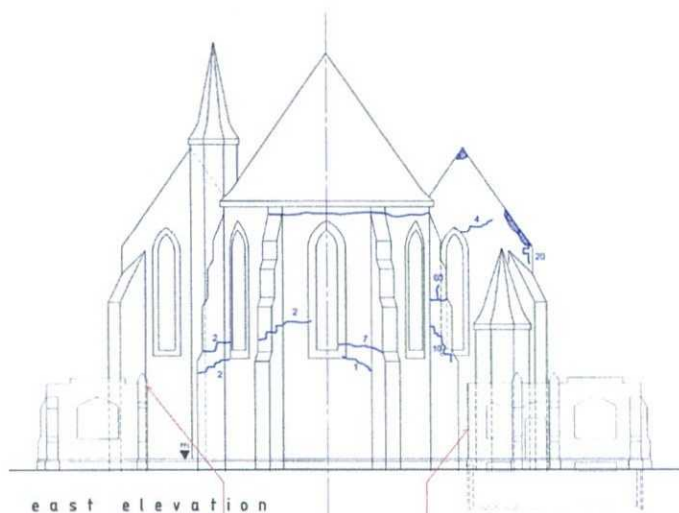
east elevation

MORE CRACKS
AT ROOF LEVEL
