CHRISTCHURCH CATHEDRAL

CURRENT STATUS

FEBRUARY 13TH, 2014

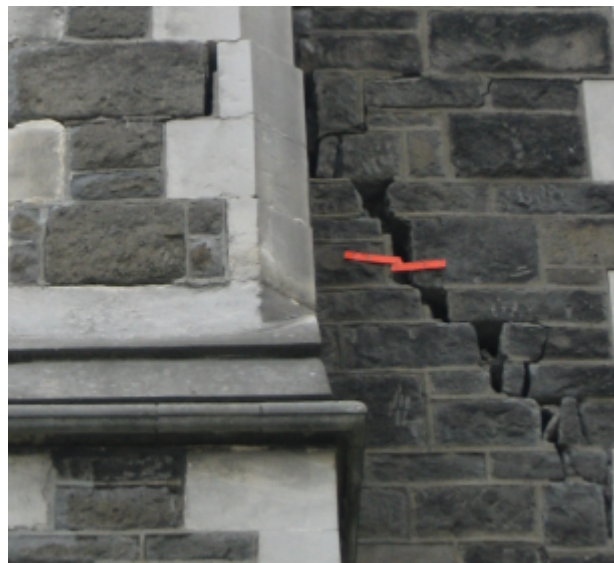
Figure 1: South transept wall, January 14, 2013

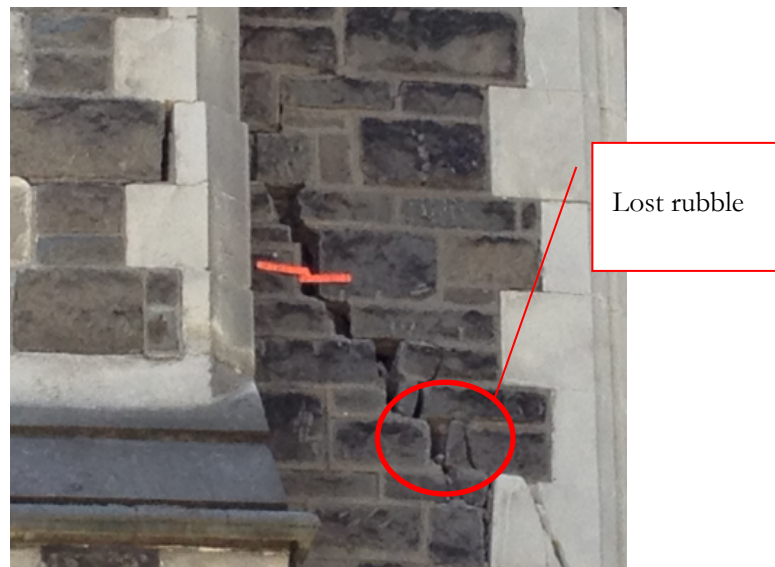
1. Some more glass has fallen from a leadlight window to the east of the organ loft. This may have been the outcome of further shaking or may easily have resulted from wind.
2. A small amount of rubble has fallen from a cracked area on the south transept wall – see Figures 1 and 2 below

Figure 2: South transept wall, February 3, 2014

4. The south side aisle has significant diagonal cracking to the piers with some partial collapse of the buttresses.
5. The south transept wall has sliding failures with displacements estimated to be in excess of 50mm.
6. The north wall of the apse has significant cracking to the piers with an offset in on pier in excess of 50mm in-plane and out-of-plane.
7. The interior columns supporting the nave (when last seen) exhibited significant fretting and damage at top and bottom, as do the four main columns at the crossing.
