**APPENDIX 6: PEER REVIEW OF THE  
STRUCTURAL CONCEPT**

# Christ Church Cathedral

## The Stabilisation and Reinstatement of the Cathedral – Concept Review

### Overview of structural concepts

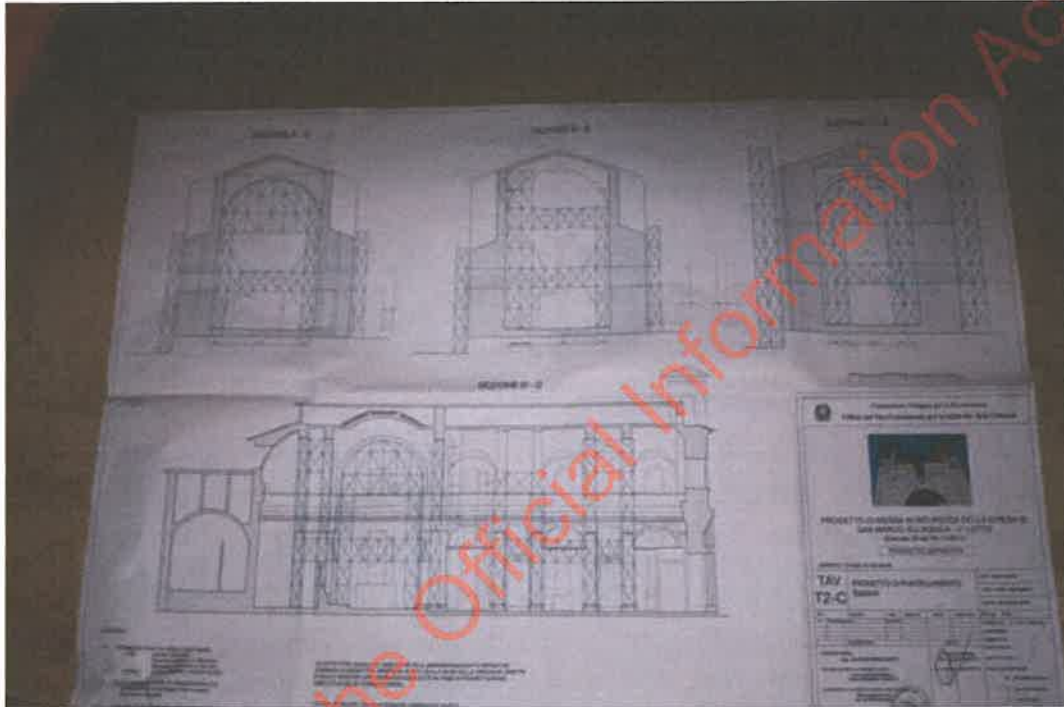
Photograph 1: Scaffold Tube Securing System: Detailed drawings for construction of internal skeleton.

Another option that could be considered is to use supporting frames fabricated from 40mm dia galvanized scaffolding tube with clamp connections. The strength and stiffness of these supporting frames can be designed to provide the required strength demand, have a stiffness that allows some flexing of the supported masonry so as to reduce any pounding effect, and allow redistribution of stresses through the masonry. The scaffolding support structures shown in Appendix 1 are to a sophisticated design, but simple to construct using standard elements, easily modified to meet site requirements, and readily dismantled for alternative use when no longer required.

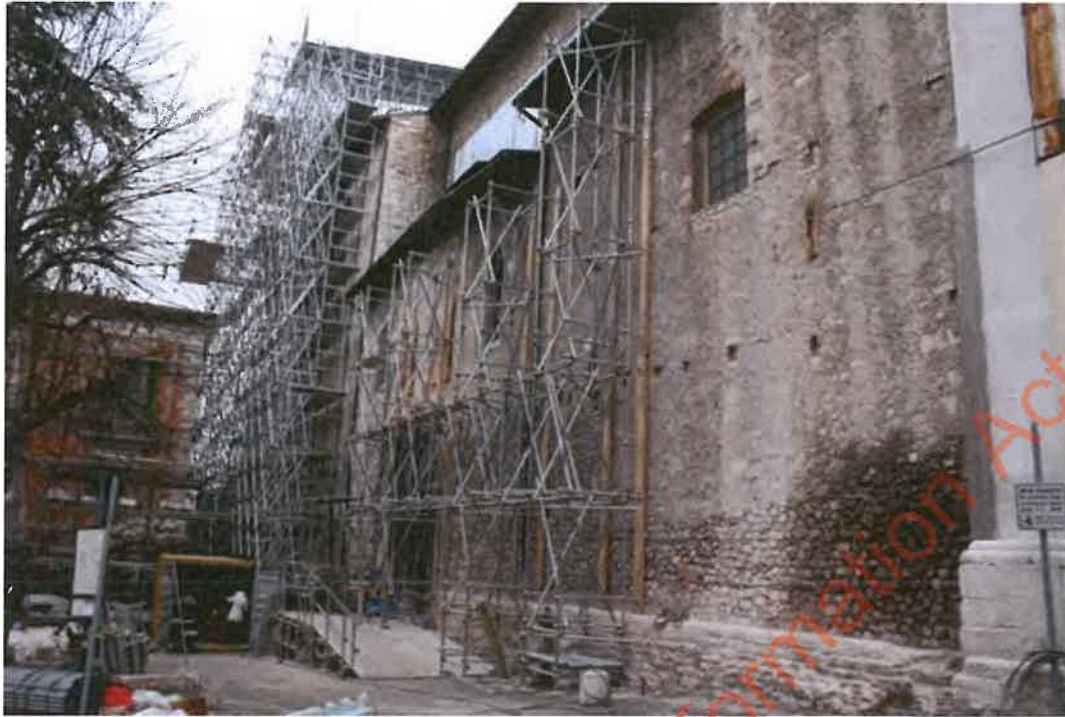
**Photograph 2: San Marco's Church: External Skeleton**

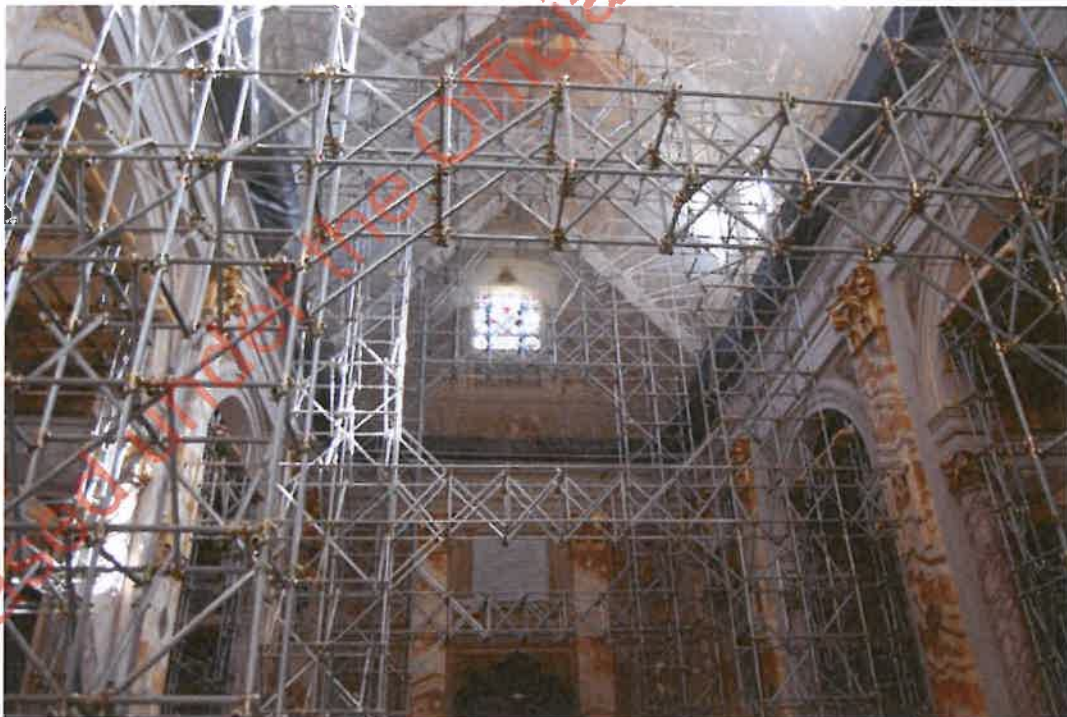
**Photograph 3: San Marco's Church: Internal Skeleton**

**External and Internal Skeleton clamped together with steel wire cables.**

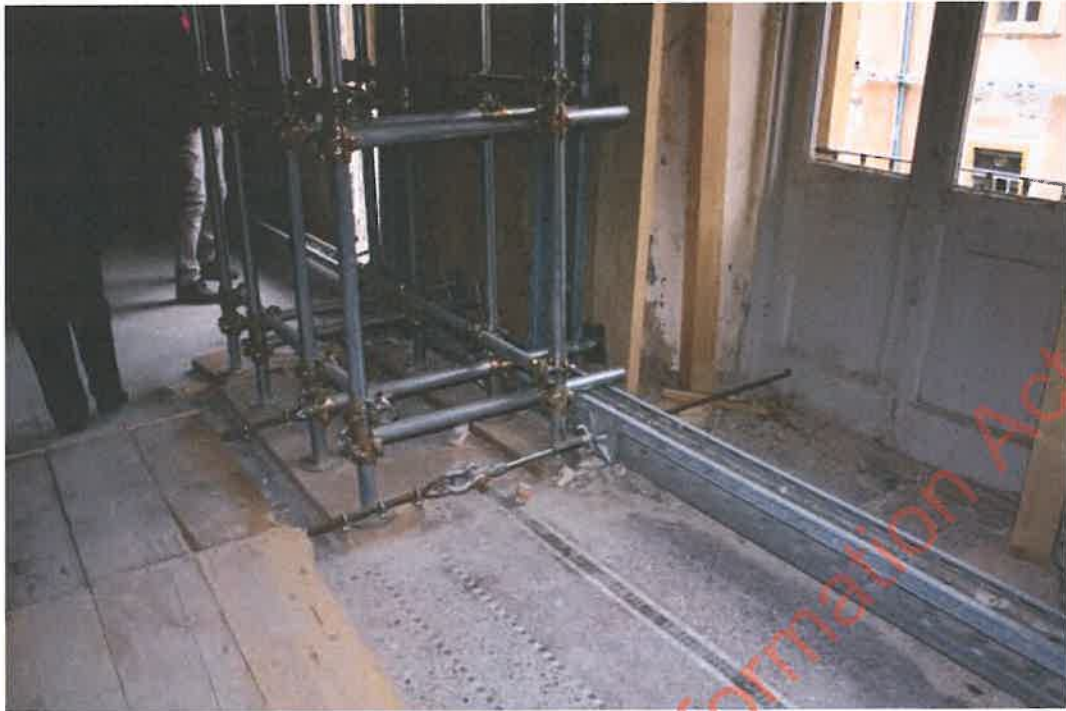
**Photograph 4: Masonry clamped between inner and outer tubular towers**  
 Note wire ties above floor level clamping building together as a whole.

frames packed and clamped to ensure the masonry does not disintegrate due to the earthquake effects. In this way the support frames are not required to carry the full earthquake inertia load from the masonry.

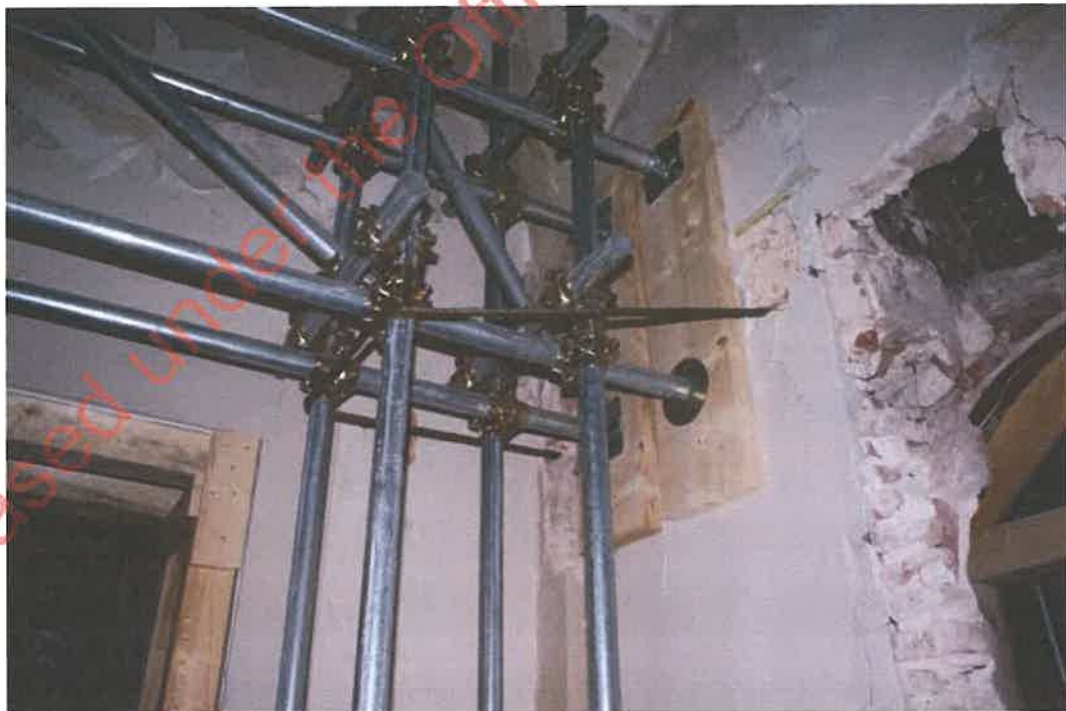
**Photograph 5: Further detail of clamping masonry**

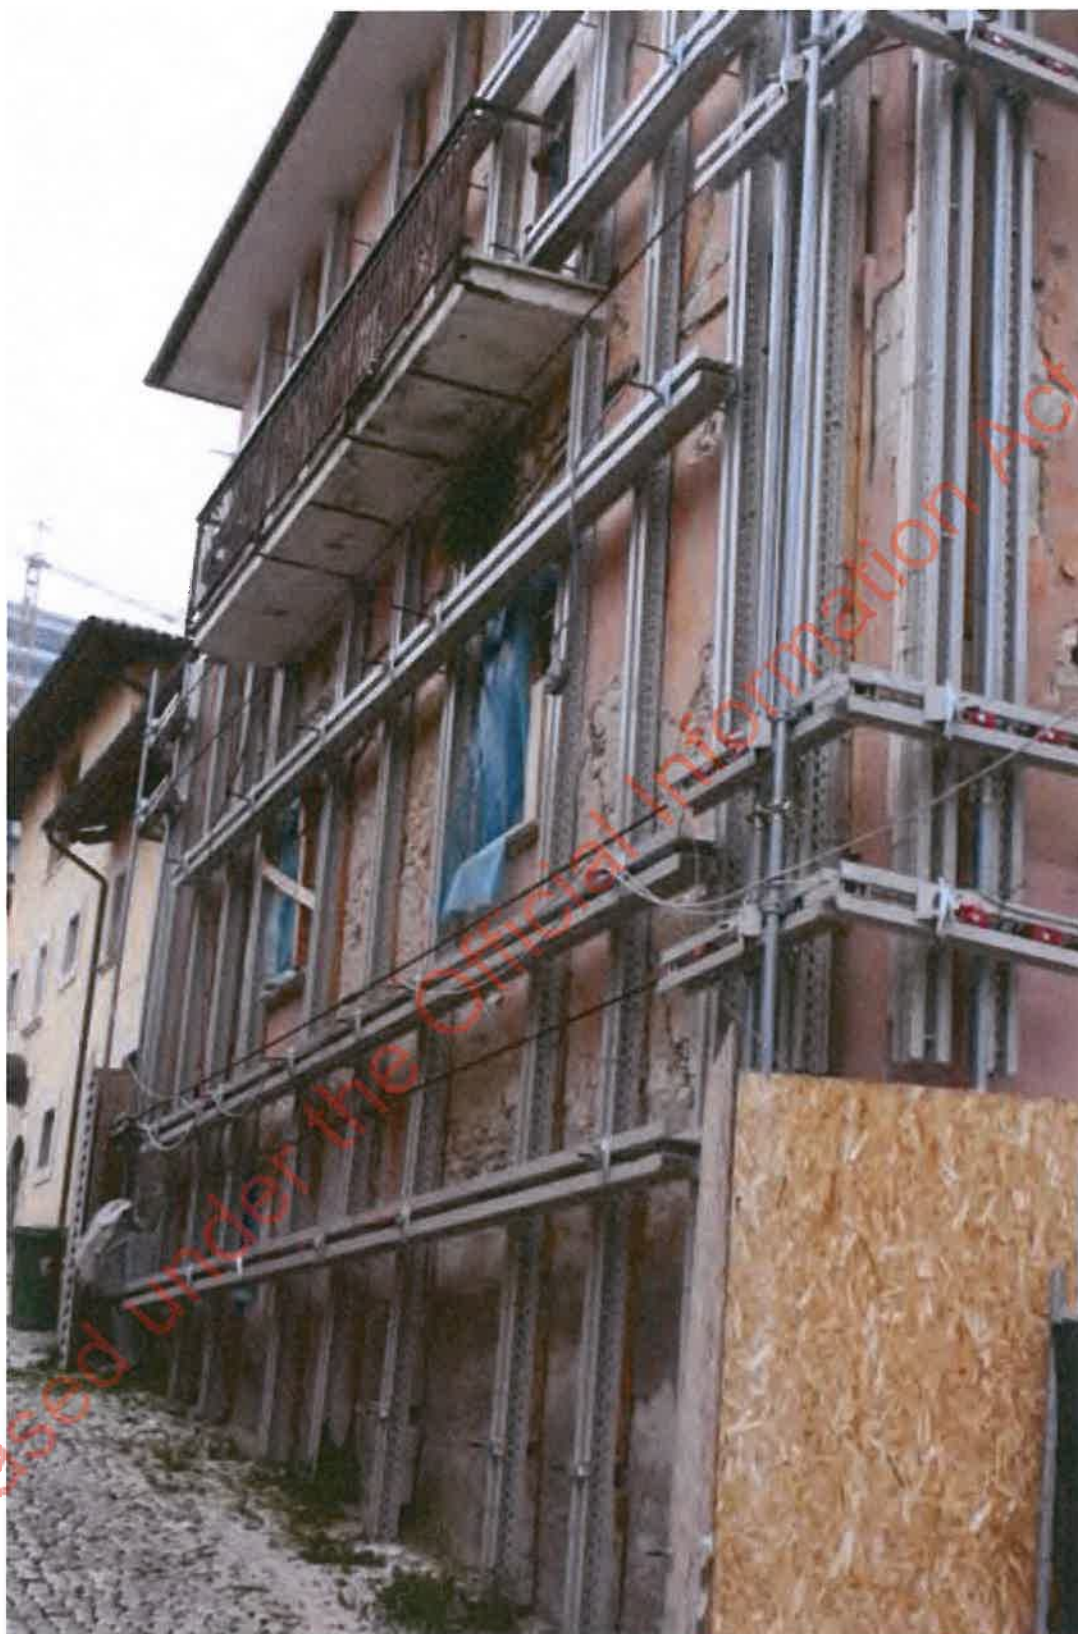
**Photograph 6: Ties through building to external frames to clamp masonry building together.**

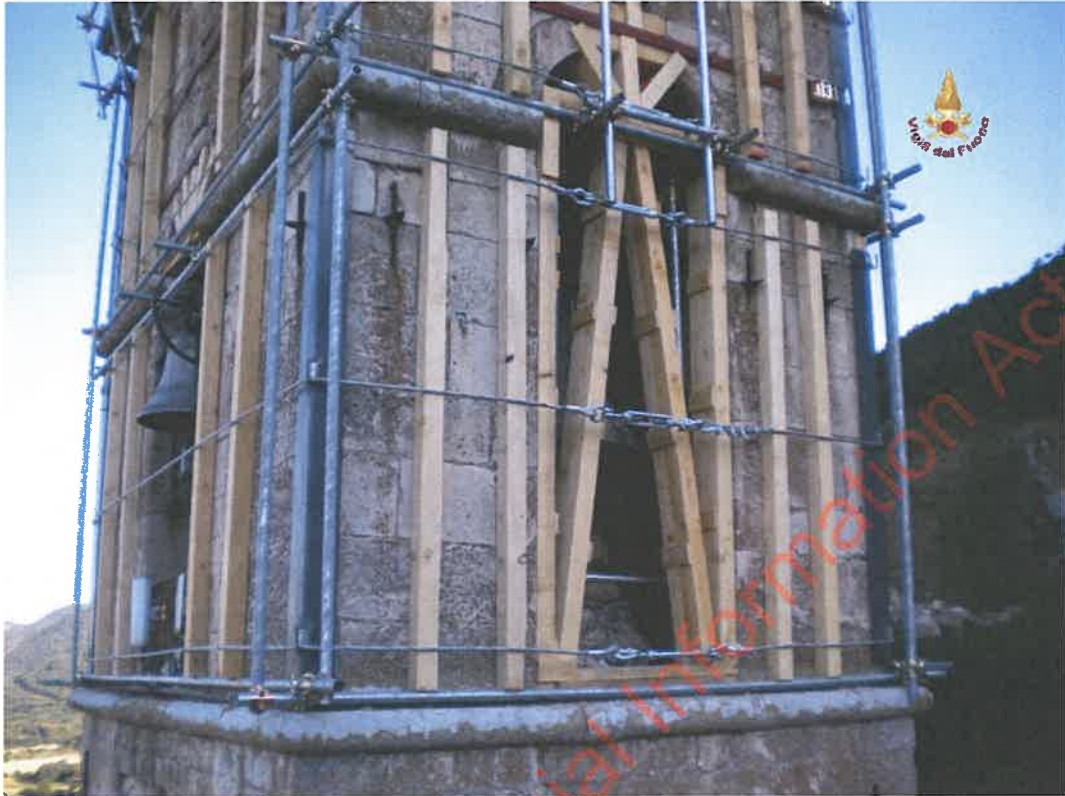
**Photograph 7: Tower clamped together with external perimeter ties, and openings strutted with timber framing.**

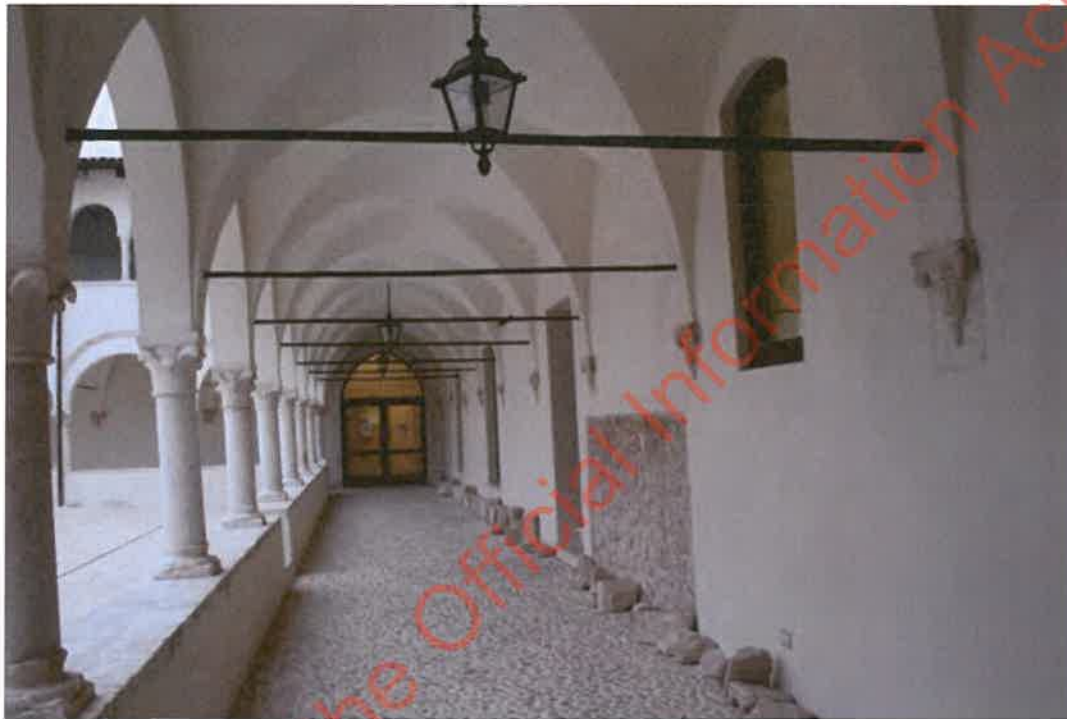
**Photograph 1: 13<sup>th</sup> Century Monastery structural strengthened in 2007**

**Section of stone rubble masonry left exposed halfway down aisle.**

**Strengthening including grouting of rubble masonry core and installing transverse ties.**

Consideration could be given to overseas experience, research and practice<sup>8,9</sup> where stone masonry heritage buildings are more prevalent than in New Zealand. In Europe, they have a much longer history of dealing with stone rubble masonry buildings, and large cities populated with such buildings that have been subjected to damaging earthquake effects for centuries. In addition, over the last 15-years there were major research efforts to identify the failure mechanisms inherent in stone rubble masonry during an earthquake, and to identify structural strengthening solutions that enhance the resilience of these structures. Stone rubble masonry buildings that were strengthened using these techniques have withstood major earthquake events with little or no damage<sup>10</sup>. The key messages from this research are:

- Tie the stone rubble masonry together with such techniques as transverse ties through the thickness of the wall, and dowelling the 'L' and 'T' junctions into the body of the adjacent wall.
- Grout the void spaces within the wall fabric with flexible grouts that have high adhesion to the stone masonry.
- Provide ties around the perimeter of the building at floor and roof level.
- Provide floor and roof diaphragms tied into the perimeter masonry walls. The diaphragm horizontal load stiffness is tuned to the flexibility of the walls, but inhibits wall failure.

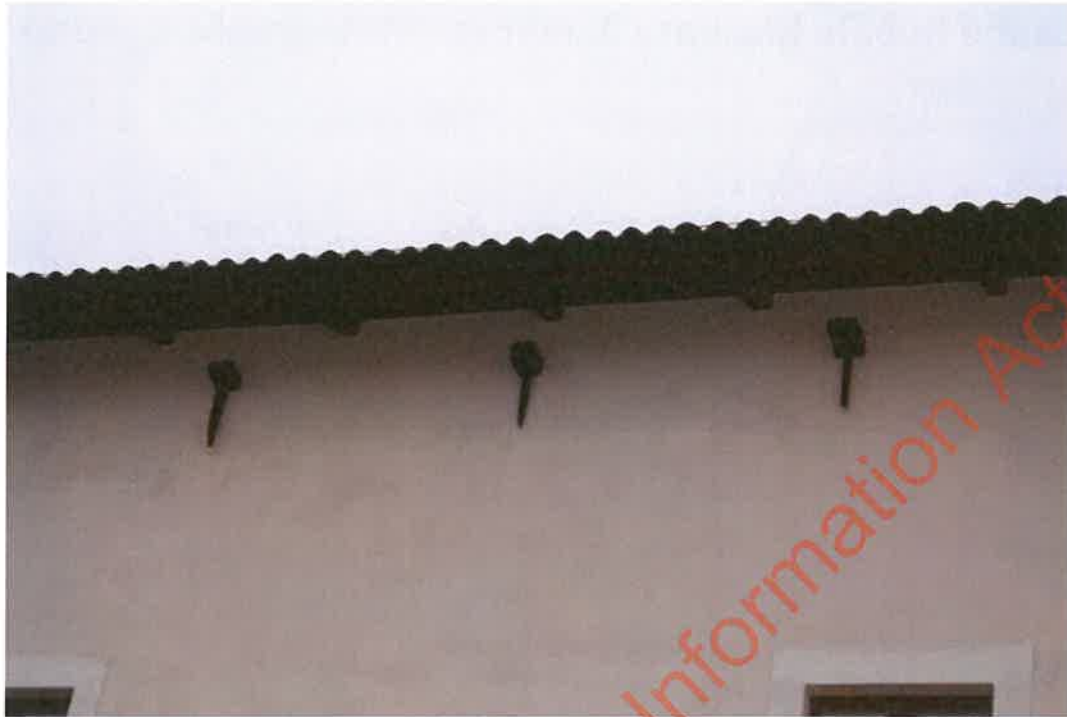
**Photograph 4: 13<sup>th</sup> Century Monastery structural strengthened in 2007**

**Original construction detail with bottom chord of roof trusses taken through masonry wall and a locking piece inserted to inhibit wall from moving outwards.**

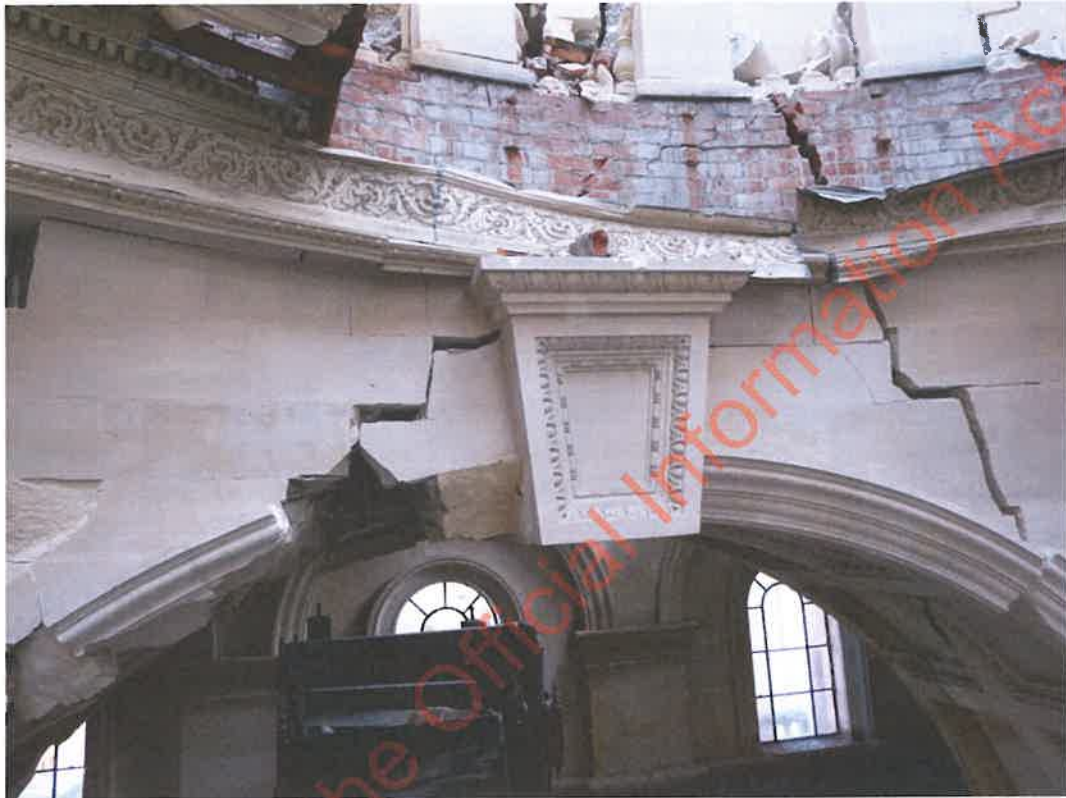
**Photograph 1: Christchurch Basilica, earthquake damage due to vertical shear-distortion up through the south arch forming the Crossing of the Nave and Transept. This distortion was due to the rocking in the east-west direction of the four columns supporting the four arches of the Crossing.**

The four arches of the Cathedral nave/transept crossing require reconstruction to allow the four main columns to sway under seismic loading, despite reduced loading due to base isolation. To allow this sway action vertical shear movement will occur up through the centre of the arches<sup>11</sup>. This is generally addressed in the Holmes report. However, it is considered that further analysis is required to determine the distortion of the frames and their stone cladding. Low-damage detail should be considered to allow movement without loss of the stone veneer.

<sup>11</sup> This vertical shear distortion up through the centre of the arches at a Crossing of a Nave and Transept was clearly demonstrated at the Christchurch Basilica. Refer Photo 1 & 2 of Appendix 3.

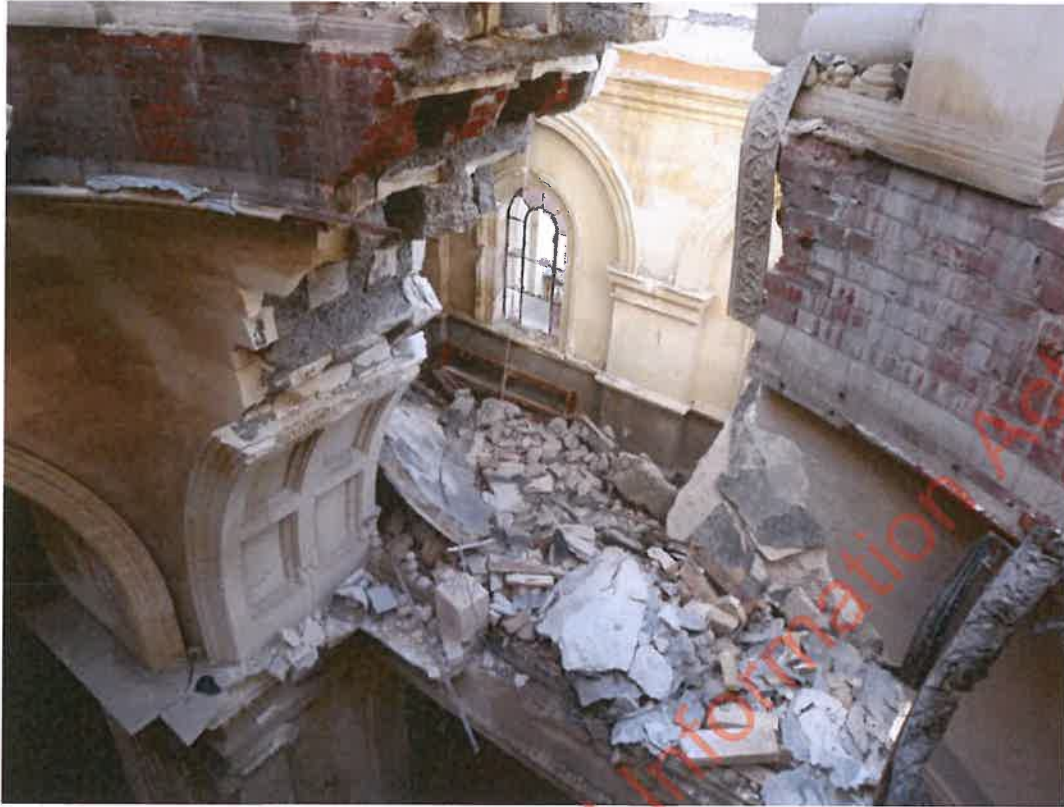
**Photograph 2: Christchurch Basilica, earthquake damage due to vertical shear-distortion up through the north arch forming the Crossing of the Nave and Transept. This distortion was due to the rocking in the east-west direction of the four columns supporting the four arches of the Crossing.**
