**APPENDIX 5: THE STABILISATION AND
REINSTATEMENT OF THE
CATHEDRAL – CONCEPT
REVIEW**

The Stabilisation and Reinstatement of the Cathedral – Concept Review

Holmes Consulting

Version 3.0
23 November 2016
Project 106324.05

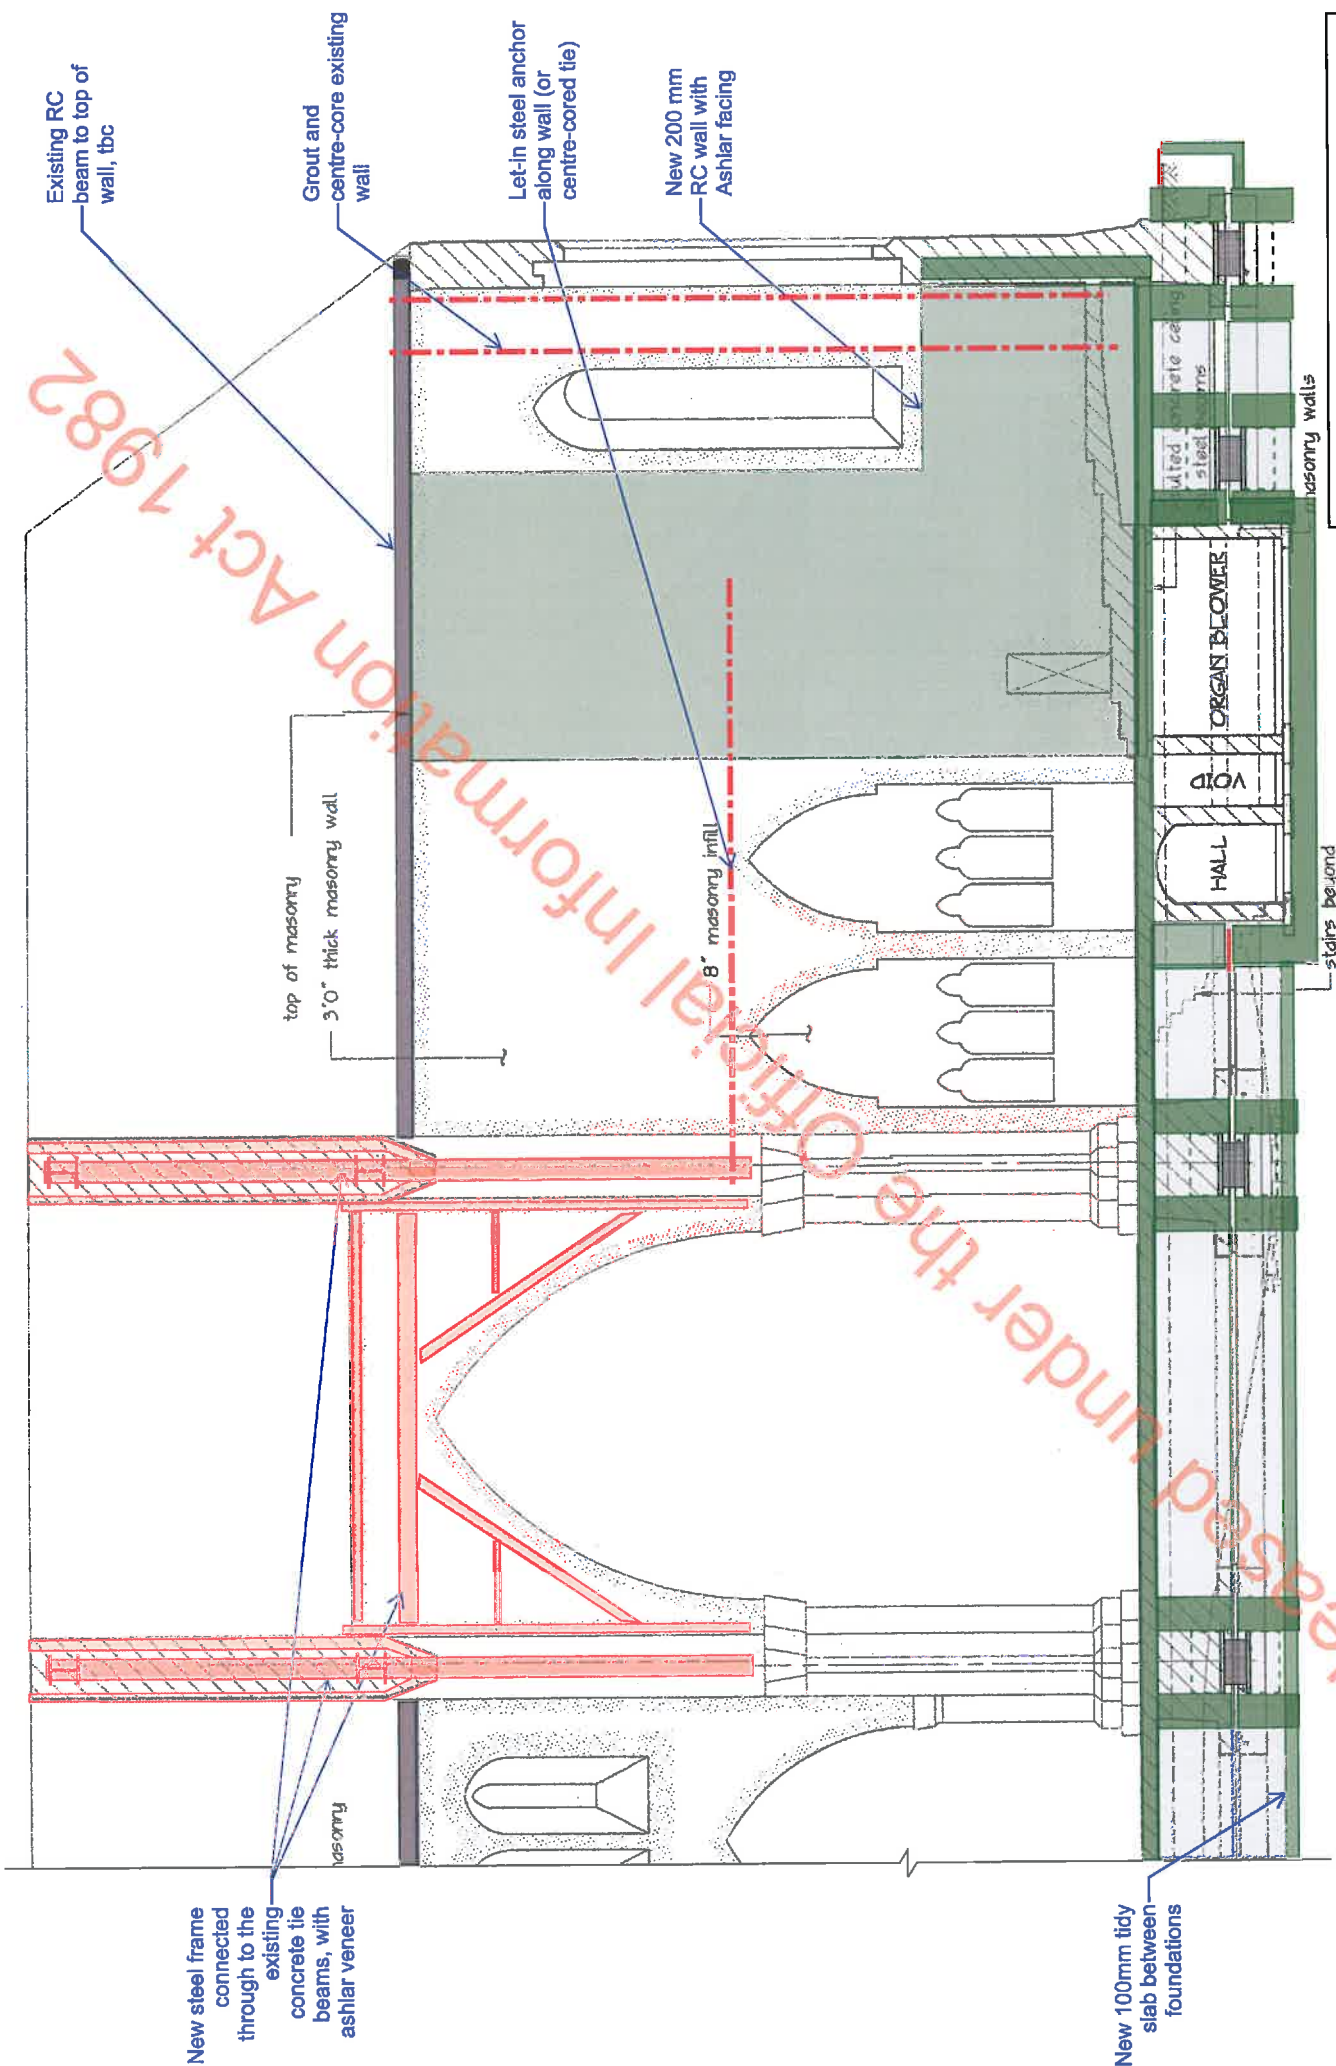
North Apse and Transept Wall
 1:100 approx

refer SSK 3-01 for
details of column
treatment

Continuous
underpinning - refer
SSK 1-01 - typical.

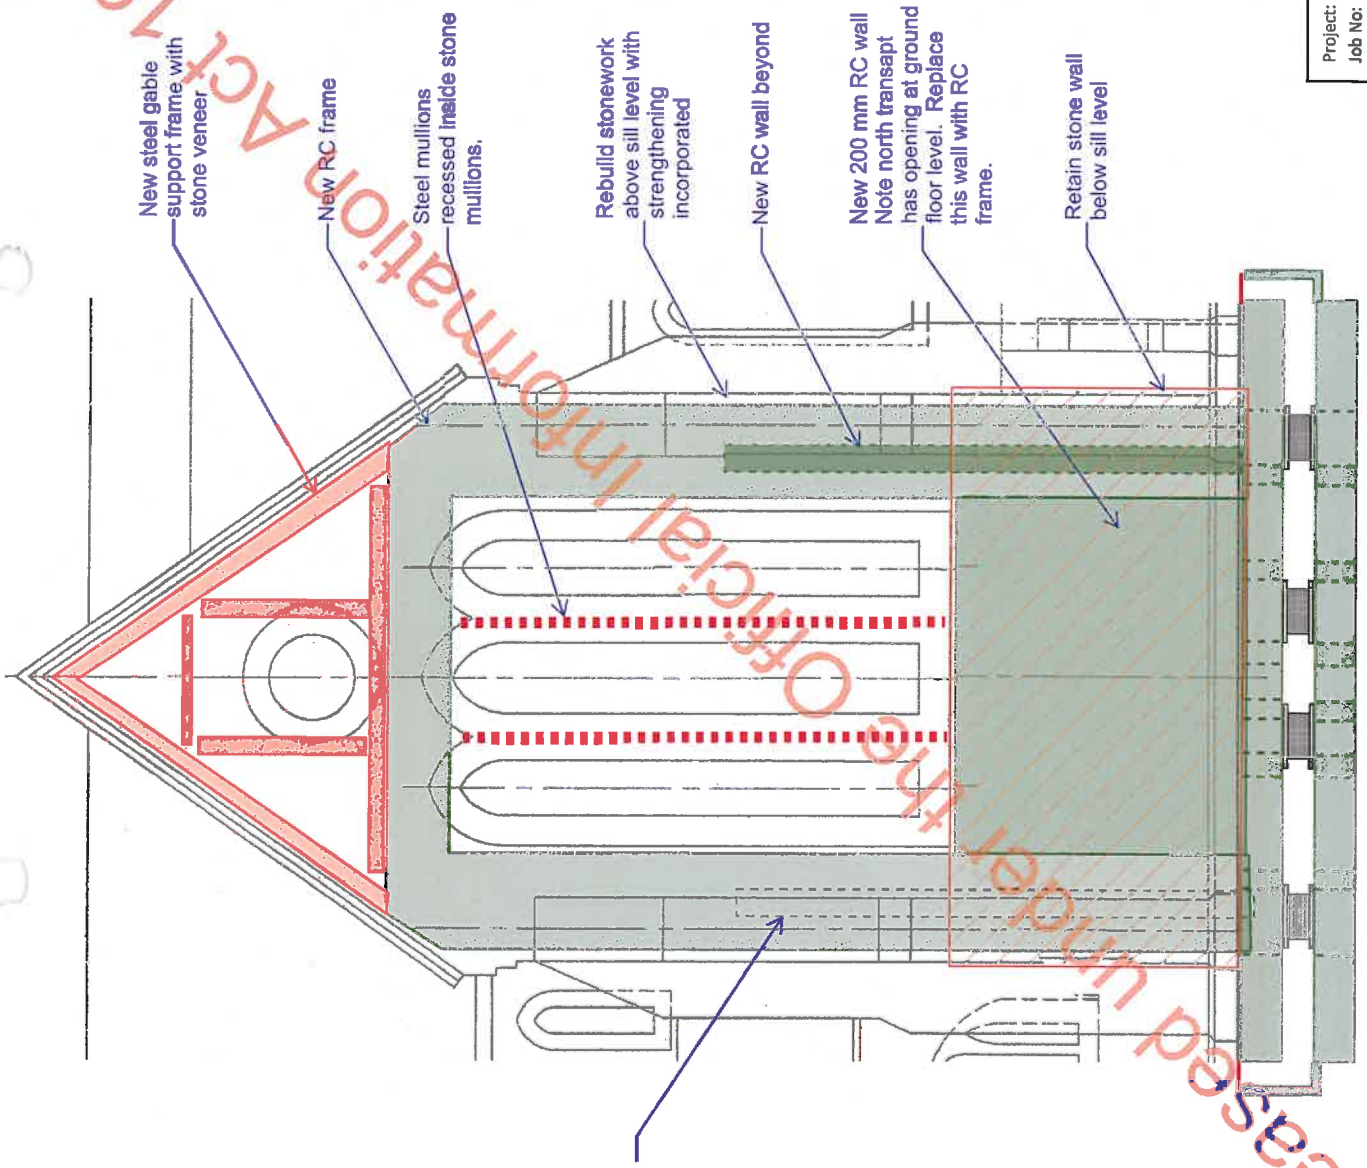
South Transept Wall (North Transept wall similar)
1:100 approx

- Lead-rubber bearing
- Sliding bearing

Ex. RC wall behind

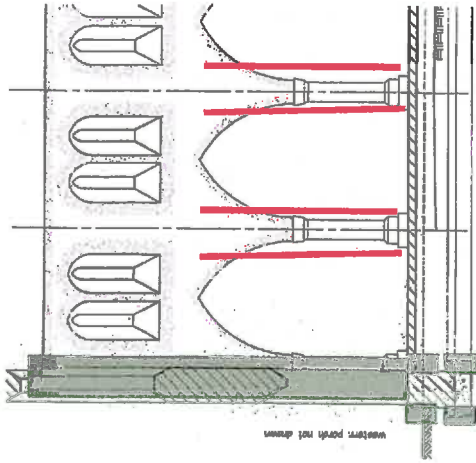
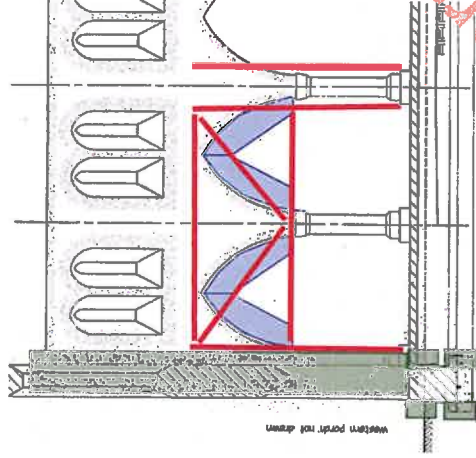
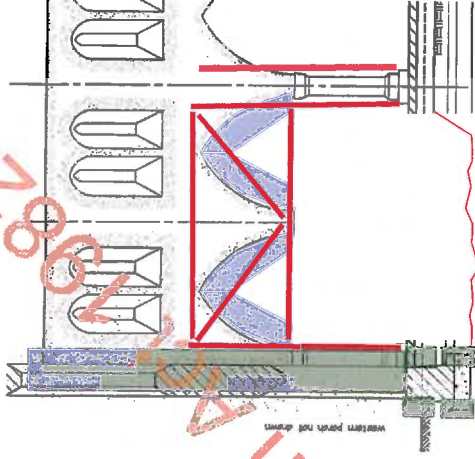
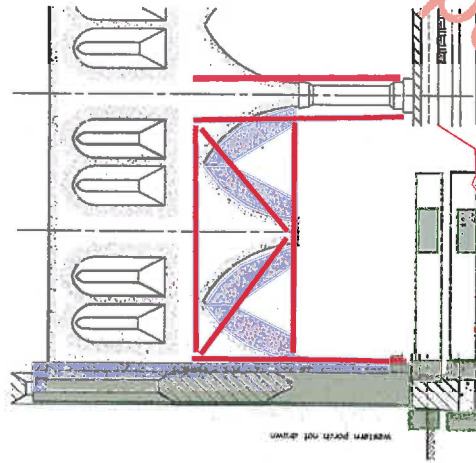
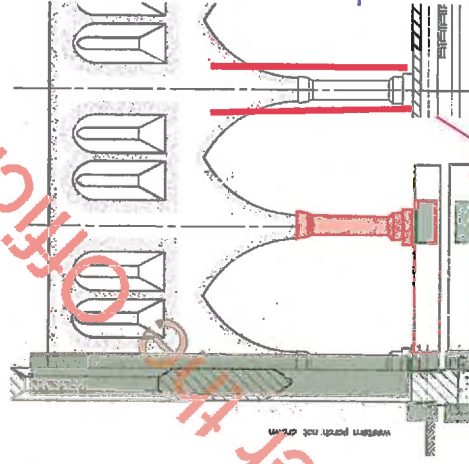
South Side Aisle Wall partial elevation
1:100 approx

2.2	Side aisle walls	Deconstruct to window sills and reconstruct	The wall areas between the side aisle windows have been severely damaged while the eaves zone and the area below the sills are relatively undamaged. For budgeting purposes, reconstruction of the walls above sill level is assumed and will be verified on site.

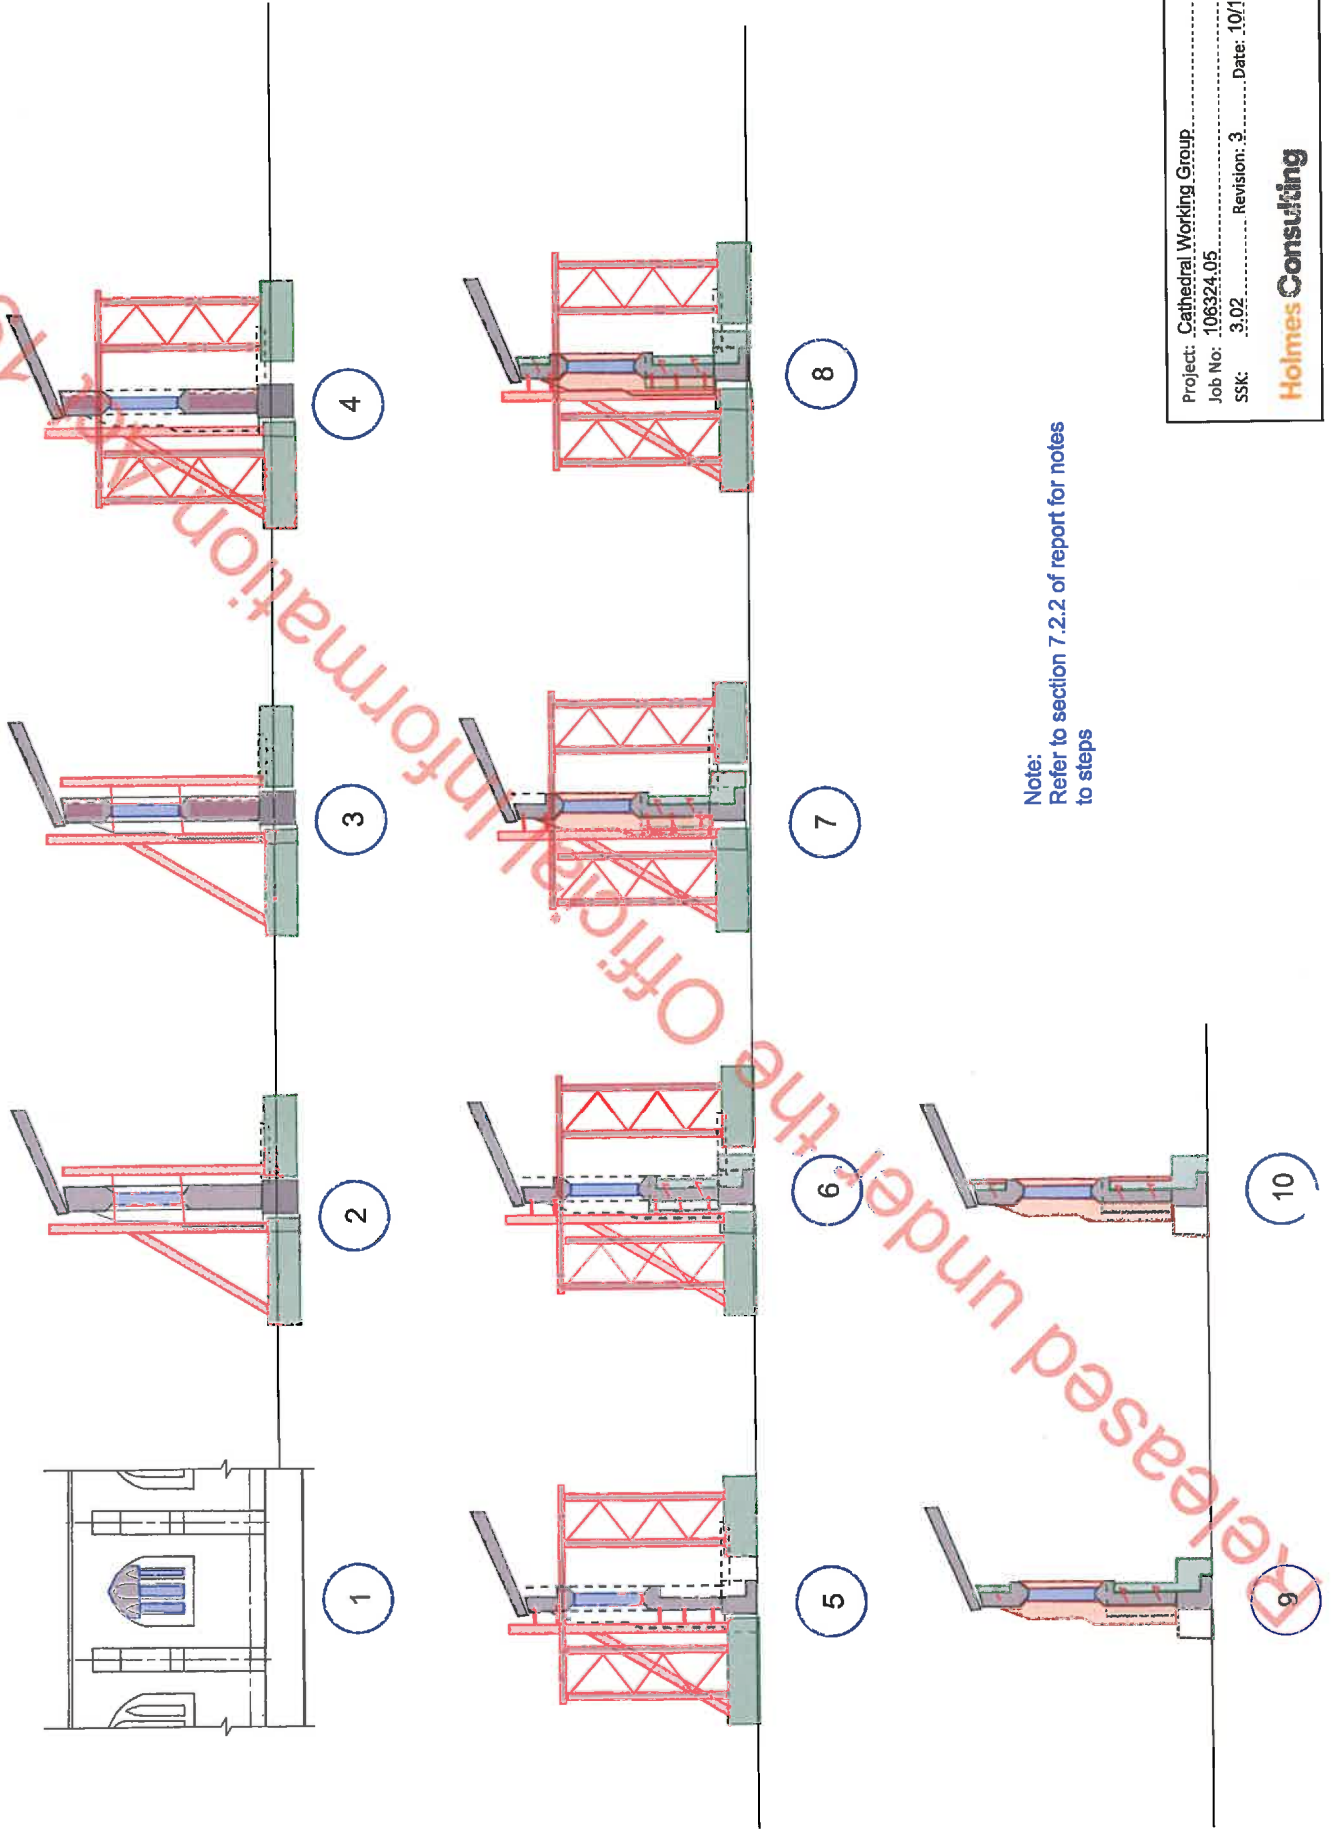
Project: Cathedral Working Group
Job No: 106324-05
SSK: 3-01
Revision: 3
Date: 10/10/2016

Replace column - refer to SSK 3-03 for steel alternative.

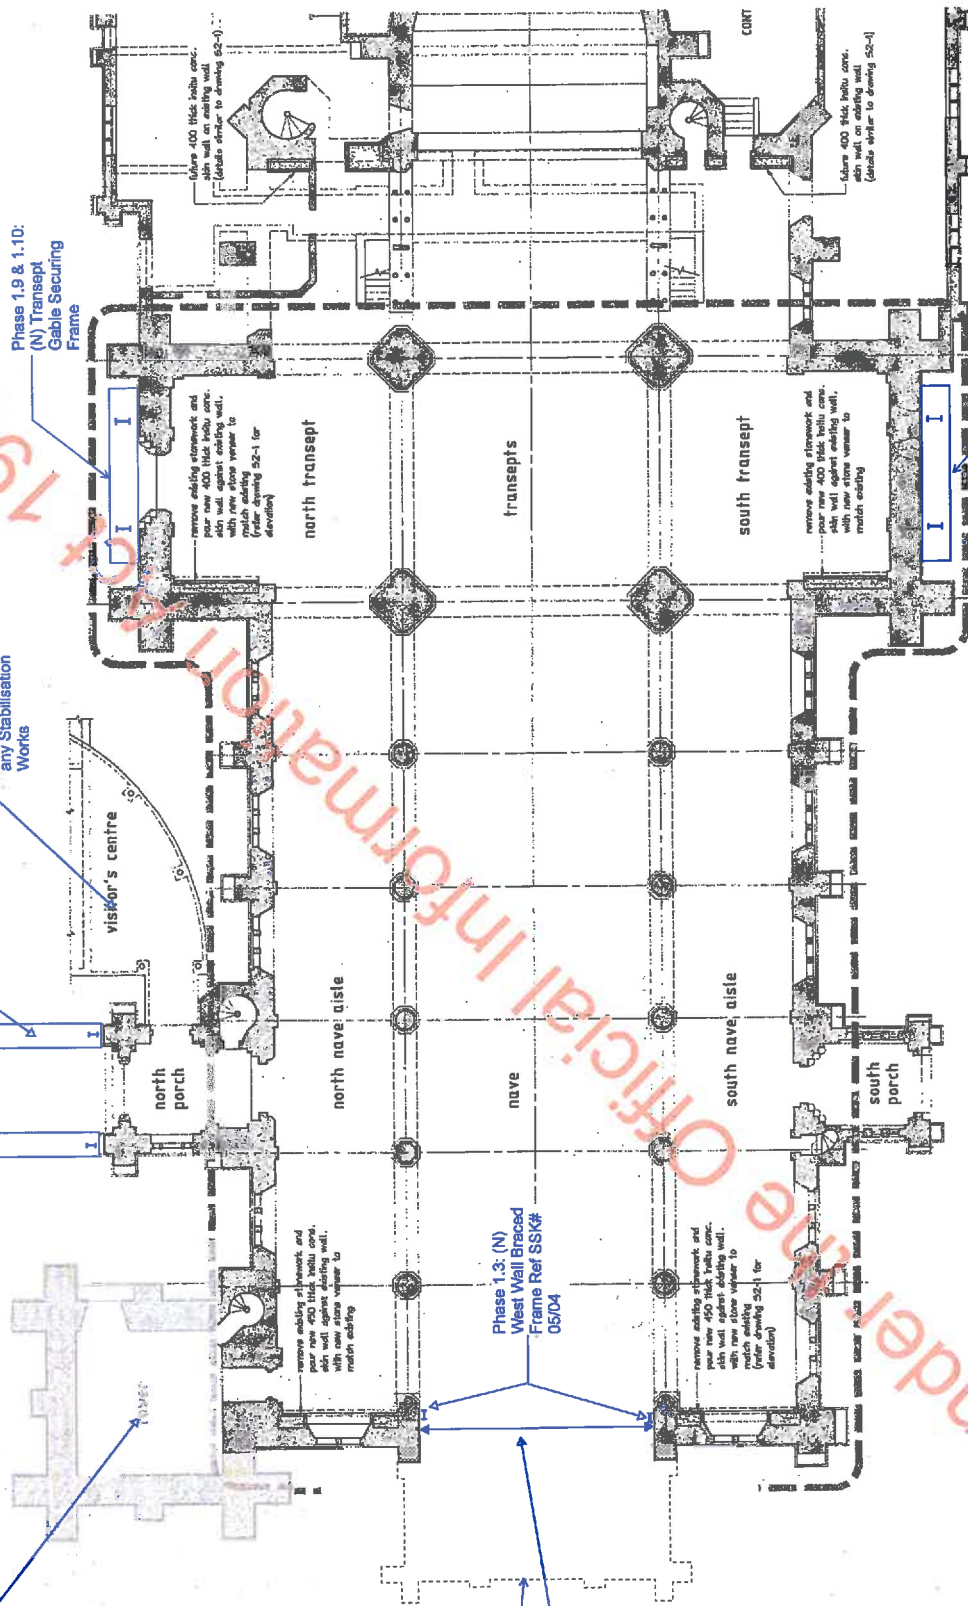
STABILISATION - PHASE 1 GROUND FLOOR PLAN

- 1.9. Remove loose masonry elements in the vicinity of the north and south transept end gables. Lift in new precast concrete foundation block for new temporary steel frames. New Transept Gable Securing Frames are intended to stabilise the badly damaged north and south transept end gables.

Phase 1.9 & 1.10:
(N) Transept
Gable Securing
Frame
