**REPORT ON FACILITATED DISCUSSIONS WITH ENGINEERS FOR CHURCH
PROPERTY TRUSTEES AND THE GREAT CHRISTCHURCH BUILDINGS TRUST ON
ENGINEERING OPTIONS FOR REPAIR, RESTORATION OR REPLACEMENT OF
CHRISTCHURCH CATHEDRAL**

Miriam R Dean:	Facilitator
John Hare:	Holmes Consulting Group LP
Adam Thornton:	Dunning Thornton Consultants Ltd

NOVEMBER 2015

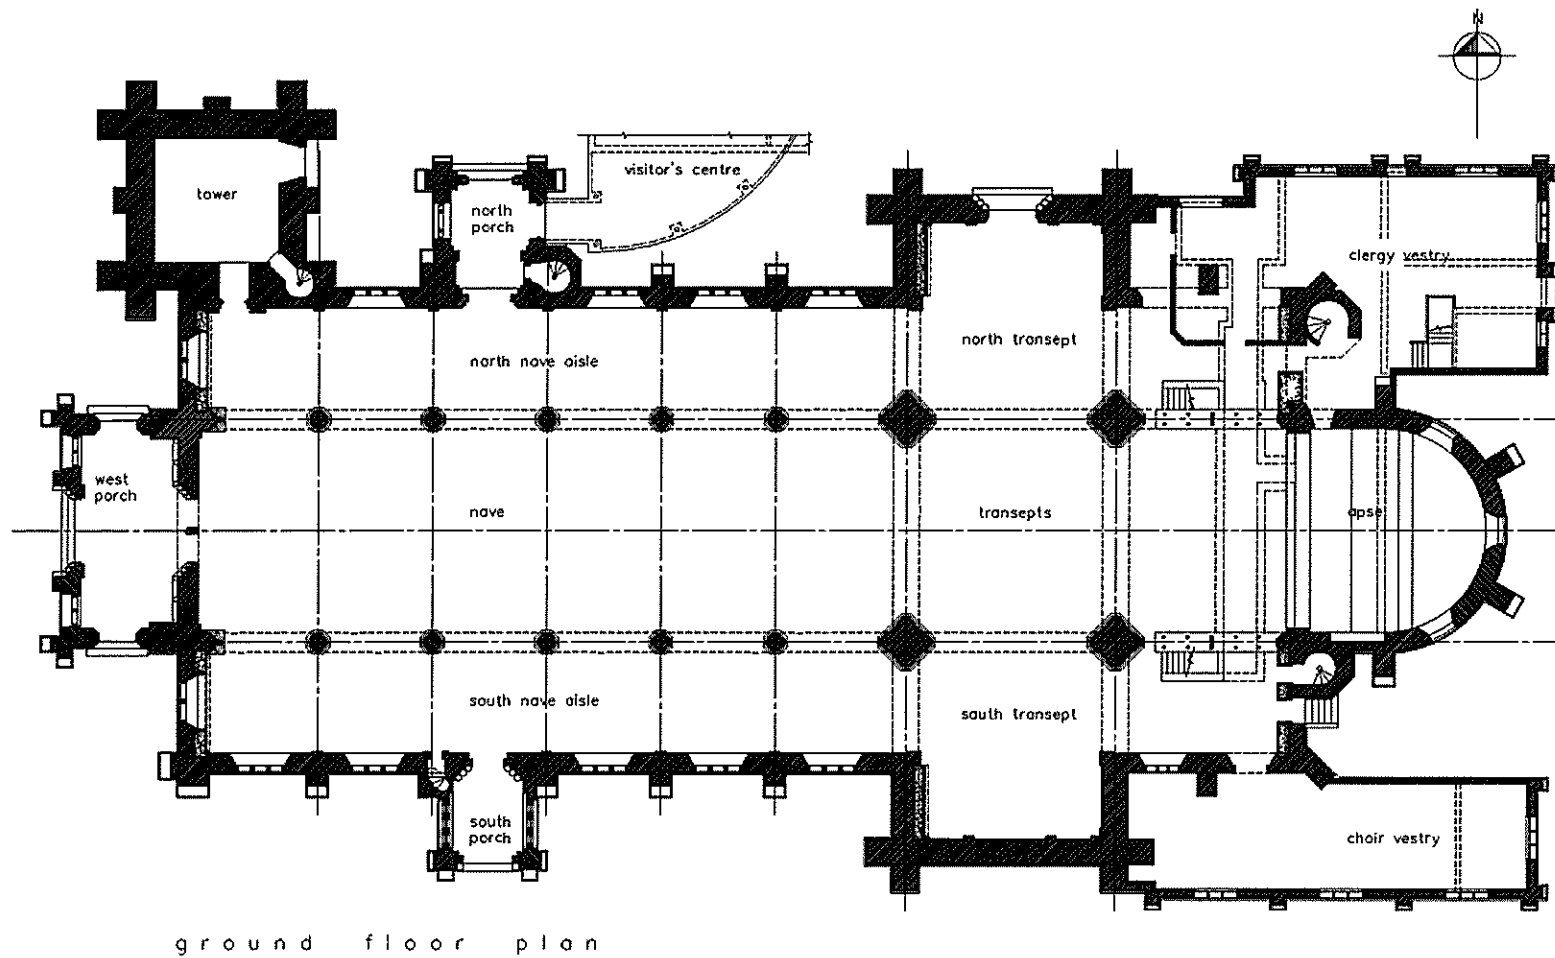
Figure 4: Damage observed to the west porch

The west porch is permanently offset from the west wall by between 20mm and 30mm. There is moderate damage to the south and west walls and significant damage to the north wall. Damage to this last wall includes parapet collapse and significant spalling (loss of small pieces of masonry) of the north-west buttress. The north portion of the roof collapsed as a result of falling tower debris.

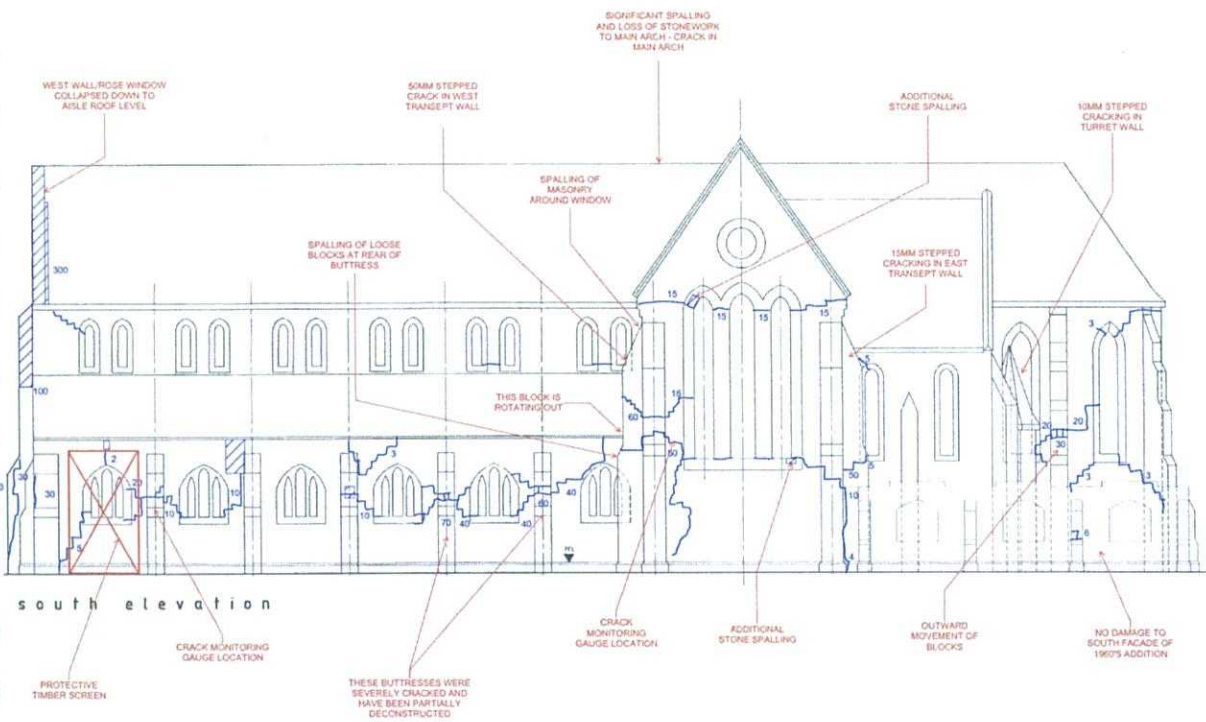
Title: South Elevation External Damage Review
 Job Name: Christchurch Cathedral Review
 Job #: 106324.04 SSK # 001
 Date: 14/01/2013 Rev 6

South wall piers and buttresses show damage similar to that observed in the north wall. However, the cracks are significantly wider (10mm to 50mm). Wider cracks in the buttresses indicate increased degradation of the walls. The projecting faces of two buttresses were removed from the face of the wall for safety. Some glass damage has occurred as a result of the structural deformations.

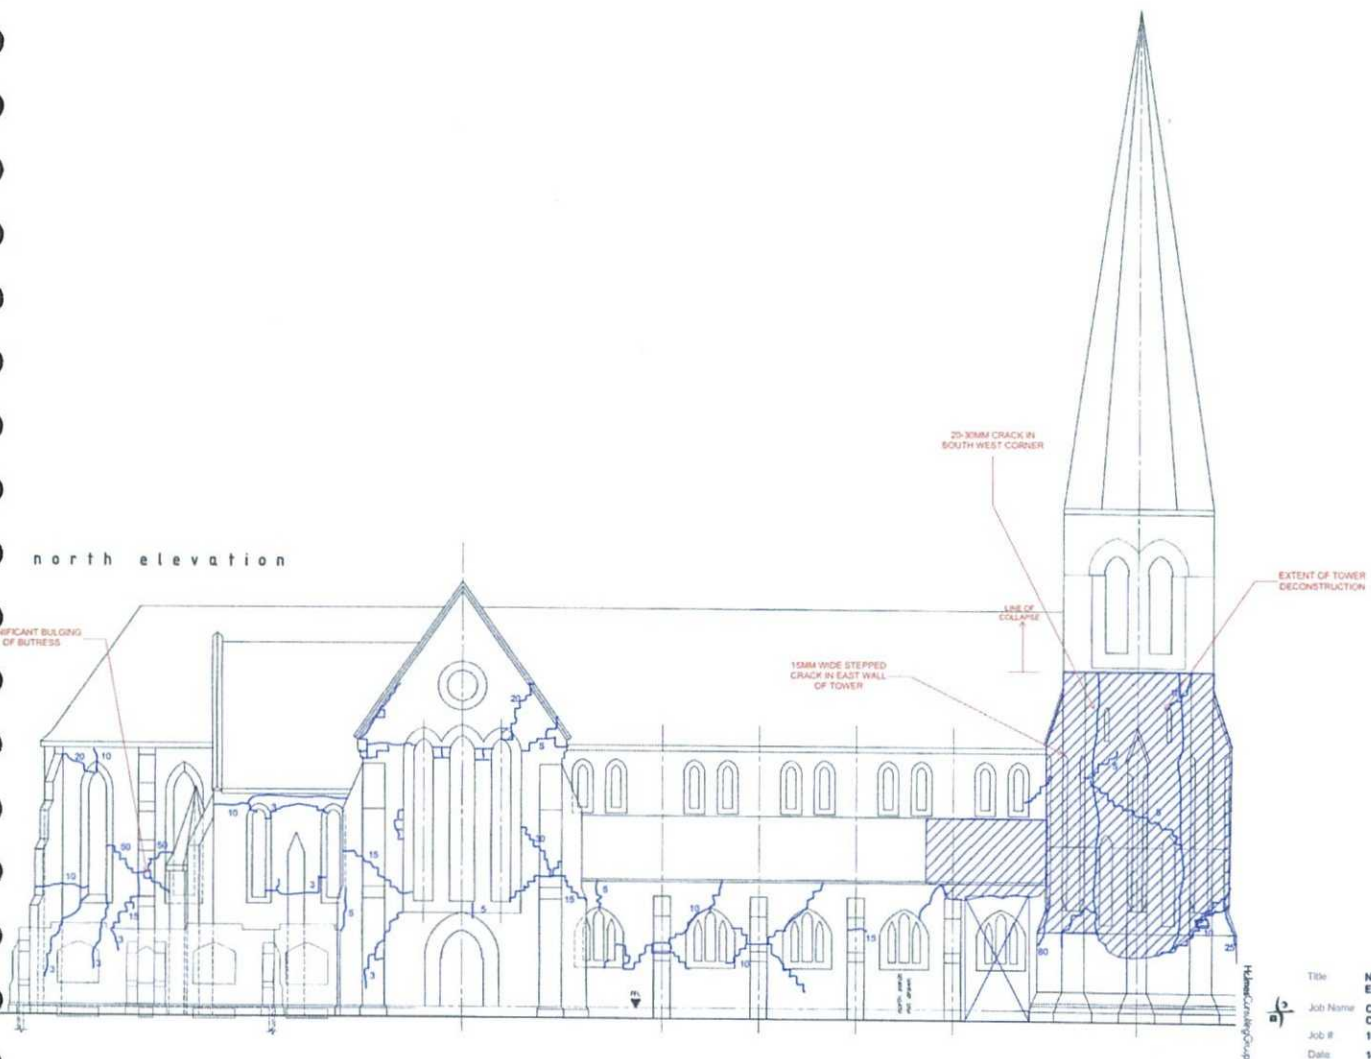
Title North Elevation
External Damage Review
Job Name Christchurch
Cathedral Review
Job # 106324.04 BSK # 002
Date 14/01/2013 Rev 6

The north wall has cracking through the wall piers and buttresses of between 5mm and 15mm.

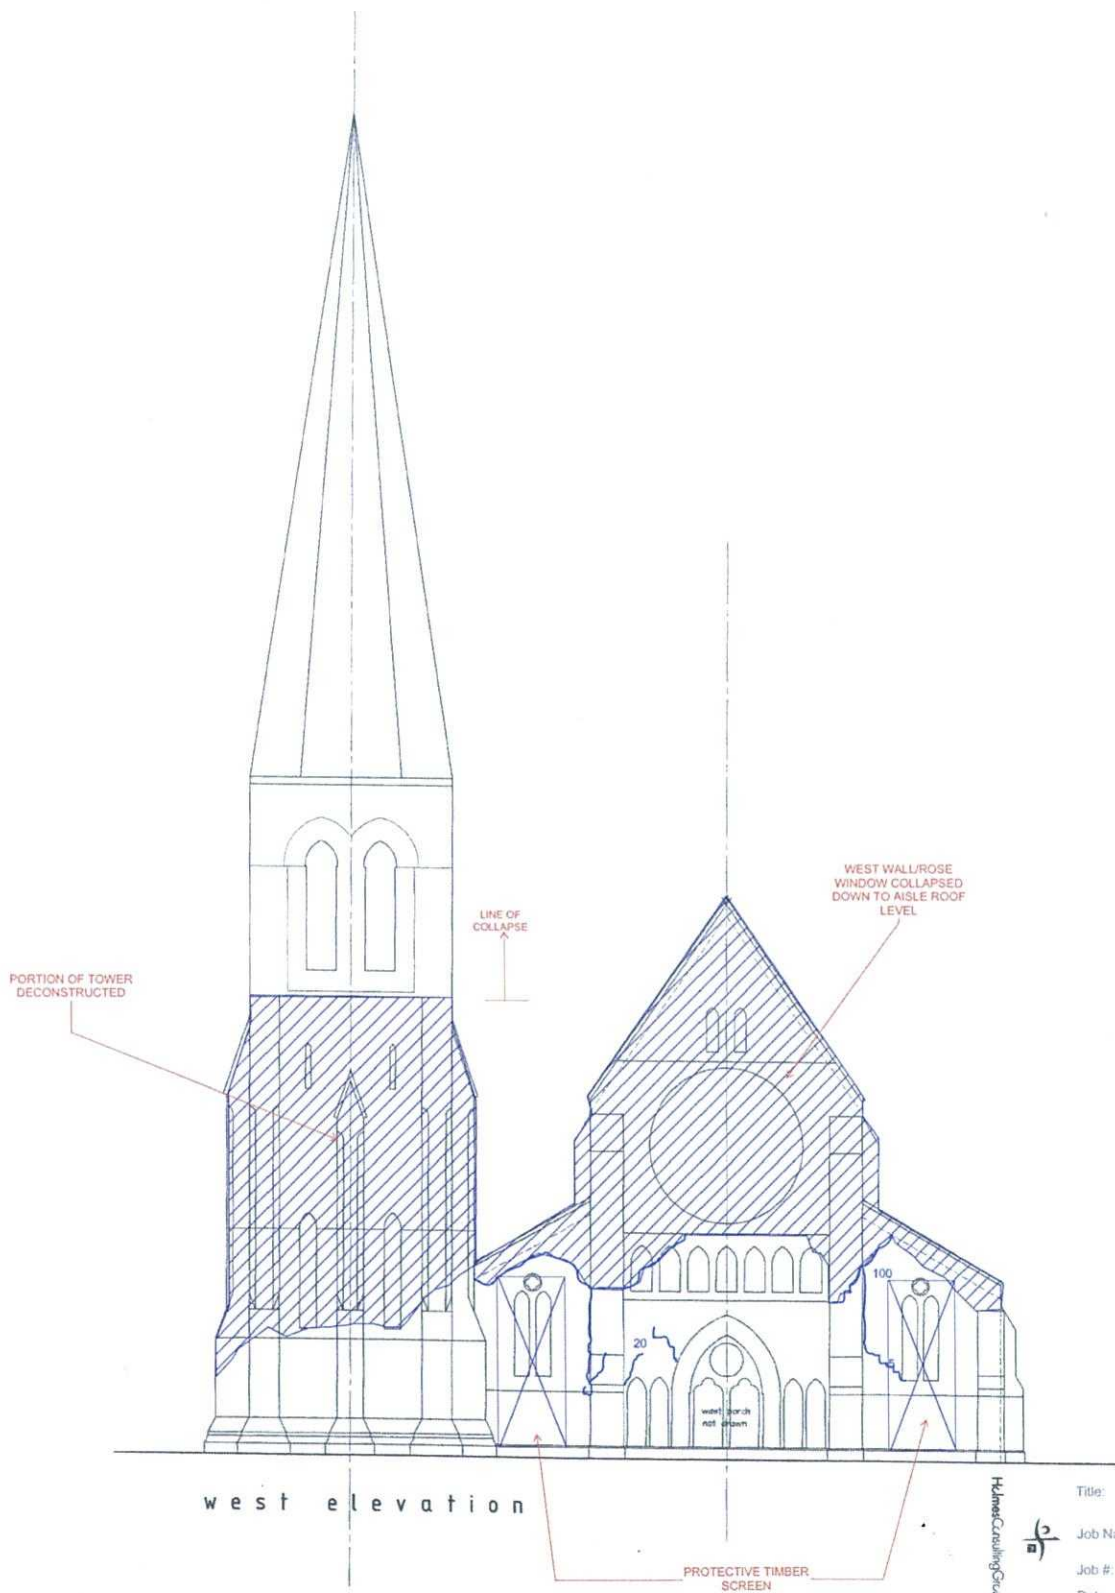
Title: West Elevation
 External Damage Review
 Job Name: Christchurch
 Cathedral Review
 Job #: 106324.04 SSK #: 003
 Date: 14/01/2013 Rev: 6

The west wall is significantly damaged. The top portion, including the rose window and buttresses, has totally collapsed. The remainder is distorted. The end walls to the side aisles are less damaged. The parapet capping stones were removed in 2011, and plywood panels in front of these walls act as protective screens to the windows. The concrete shear walls (inserted in 1999) were probably effective in preventing further damage.
