CHRISTCHURCH CATHEDRAL PROPOSED REINSTATEMENT

Archaeological Assessment of Effects
Prepared for the Cathedral Working Group
November 2016

Archaeological Assessment of Effects of the proposed reinstatement of ChristChurch Cathedral, 100 Cathedral Square, Christchurch

Prepared by Dr Andrea Farminer MCIFA, Origin Consultants Ltd

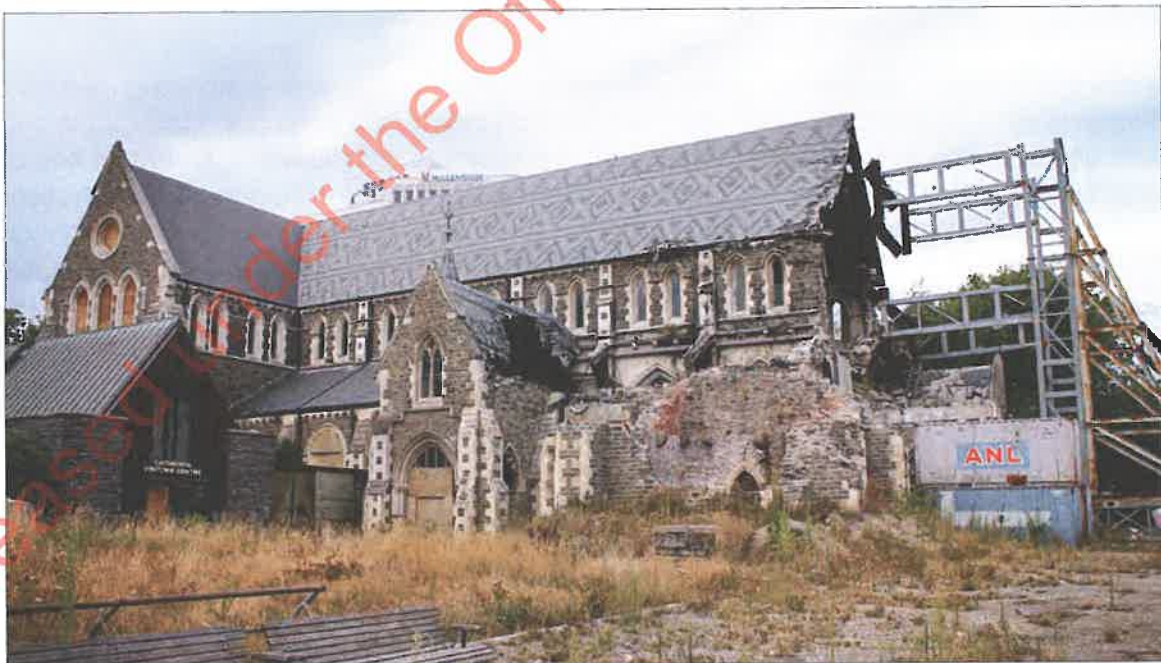
Figure 5: The Cathedral after the series of seismic events during 2011 and the partial demolition of the tower. Photograph: <http://www.vengavalevamos.com/2016/03/christchurch-new-zealand/>

The spire and upper levels of the tower were lost in the February earthquake. The tower has since been reduced in height to approximately 3 metres above the surrounding ground level (Figure 5). The construction was revealed to include large areas of solid brick masonry, rubble stone infill and cement mortar (JGA 2013).

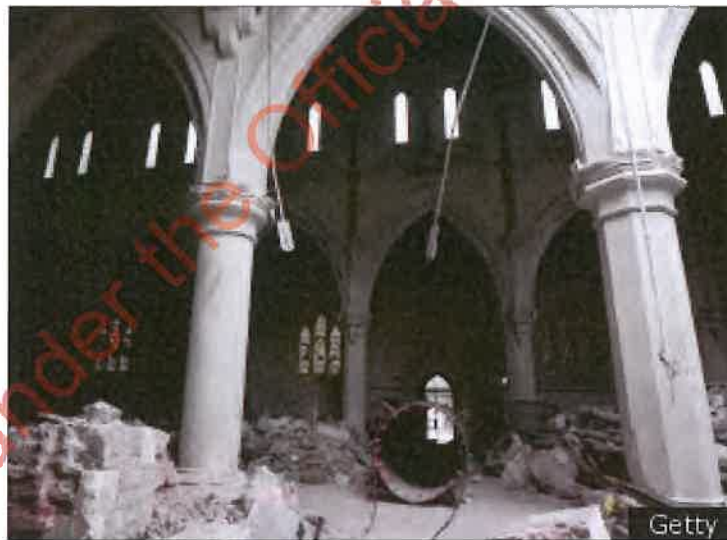
Figure 7: A view of the Cathedral interior after the earthquake with building damage and collapsed material evident. Image: Getty/Huffington Post

Inside the building there are a number of important fixtures and artefacts, including memorial tablets in stone and brass, carved timber panelling and screens, a stone pulpit, altar table and font and the effigy of Bishop Harper (Figure 6). The floors are finished with intricate patterns of encaustic tiles, including a dramatic panel leading up the centre of the nave, and illustrations of the "Four Ships" in the chancel floor. There are five panels of similar tiles at dado height on the west and north walls. At least one of these panels collapsed in the 2011 seismic events (Figure 7).

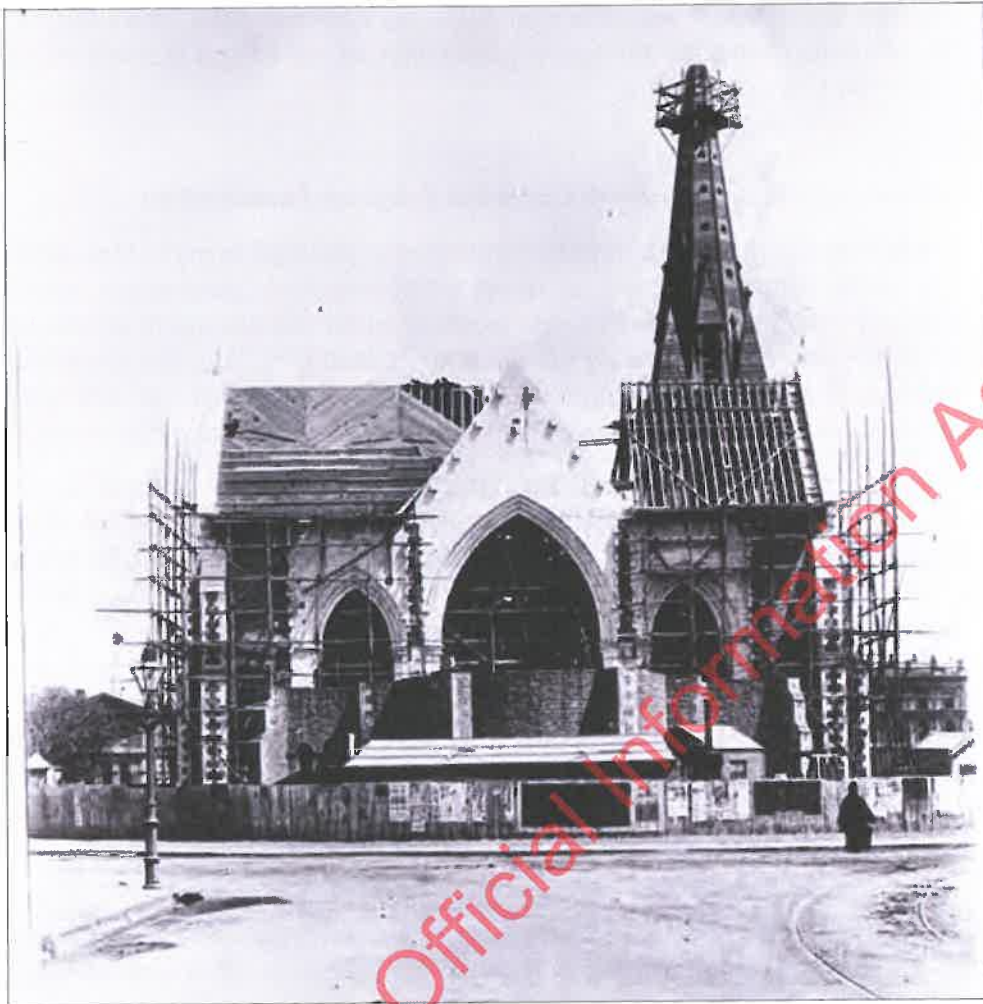
Figure 8: A view of the Cathedral under construction around 1880; the transept roofs are being erected and the eastern apse is partly built. Photograph: Christchurch City Libraries

Foundations for the cathedral were laid on 16th December 1864 under the supervision of Robert Speechly (1840-1884), after much fundraising both in England and New Zealand. Speechly, who had trained as an architect in London and worked for several leading Gothic Revival architects including William Slater and Alfred Waterhouse, was appointed resident architect to supervise the construction of the Christchurch Cathedral in 1864. The decision by the Cathedral Commission to appoint Speechly, rather than the leading local architect, Benjamin Woolfield Mountfort (1825-1898), led to an intense debate in the Christchurch newspapers. Scott supported the idea of appointing a local architect who would be familiar with the colony's conditions, and he was impressed by what he knew of Mountfort's buildings. However, the Cathedral Commission declined to accept Scott's advice, reiterating instead their concerns about the abilities of local architects (Figure 8).

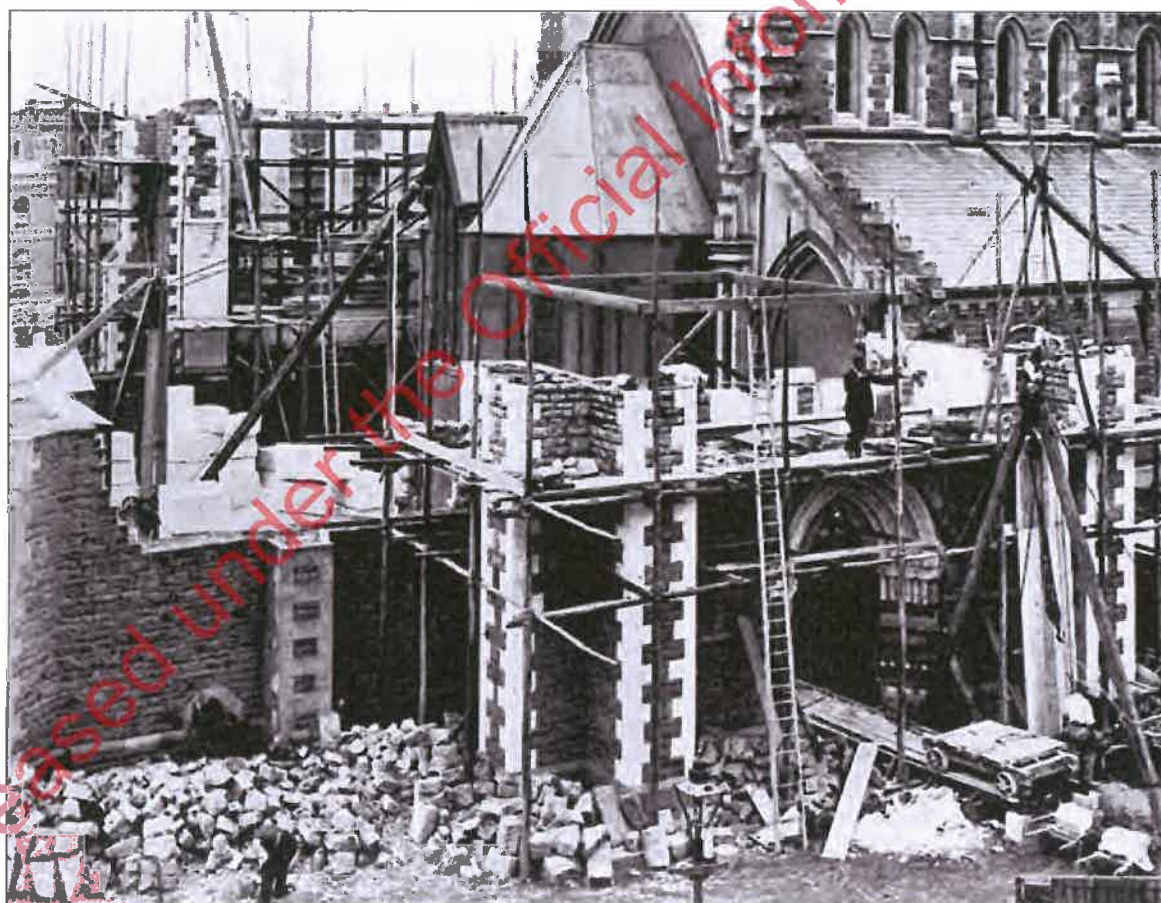
Figure 9: The chancel and apse under construction circa 1901. Photograph: Christchurch City Libraries

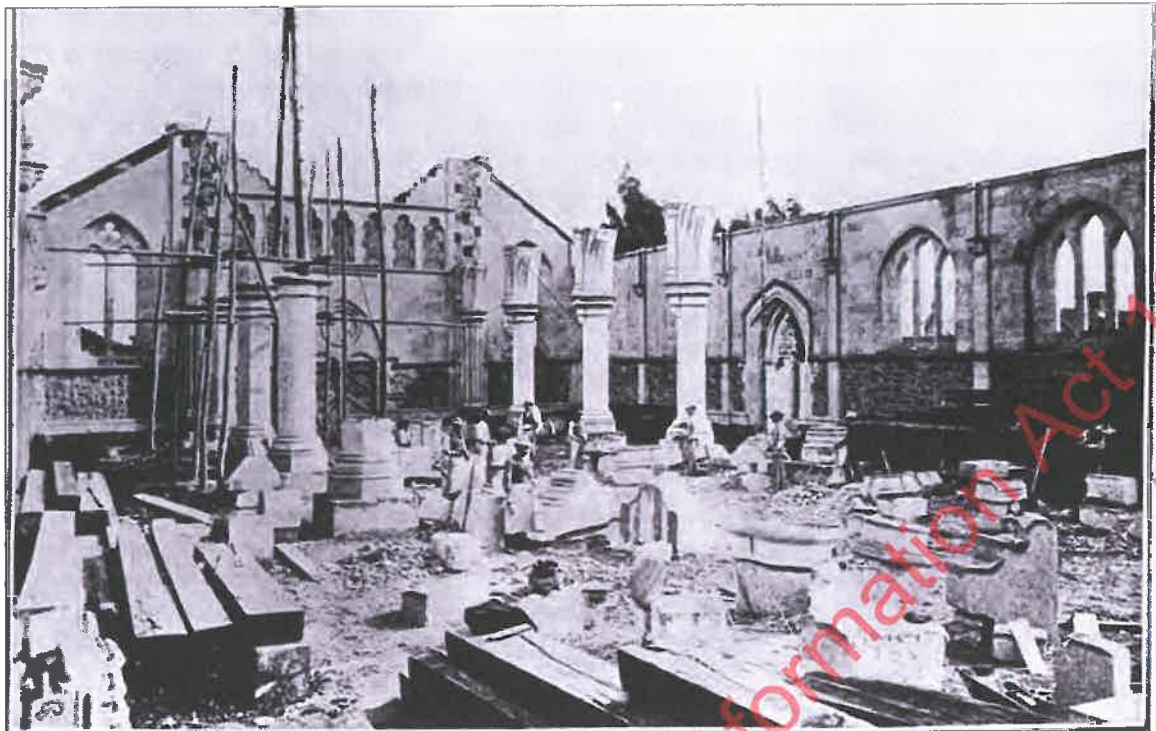
CHRISTCHURCH CATHEDRAL AS IT APPEARED IN 1878, THREE YEARS AFTER THE FIRST SERVICE IN IT WAS HELD

Figure 11: An interior view of the Cathedral nave under construction circa 1878, looking towards the western end. The concrete bases for the stone columns are visible although the foundation level below the unfinished walls is harder to distinguish. Photograph: Christchurch City Libraries

- The finished surface of the 'concrete' foundations were described as though of 'solid rock'.
- An 1878 reference (Press, 5 June 1878, page 4) noted that the base of the nave columns (weighing 1.5 tonnes) each had a concrete foundation (Figures 11 and 12).

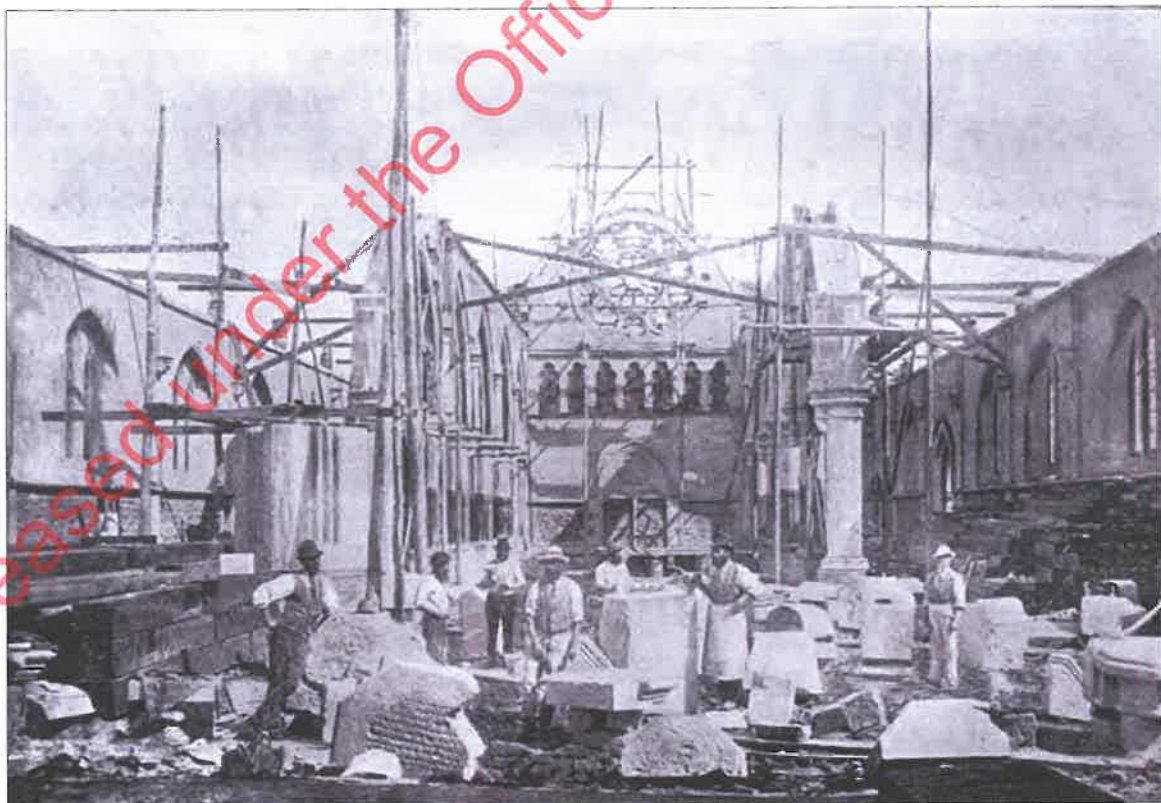
Figure 12: A slightly later view of the interior progress taken circa 1879 with the Rose window under construction. Photograph: Christchurch City Libraries

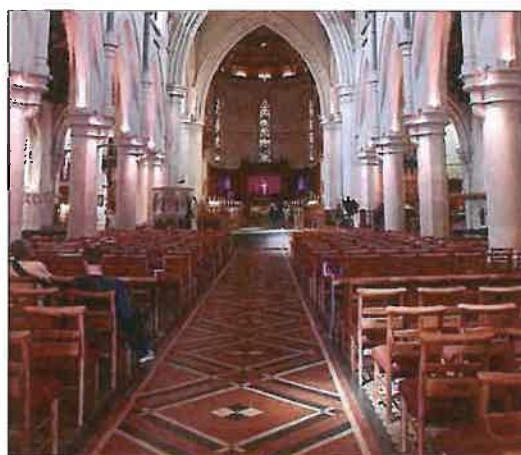
Figure 13: A view of the nave floor with the Minton tile covering. Image: www.eyeofthefish.org

This implies that there is little in the way of a sub-floor space beneath the floor surface with the 'floor' formed in concrete. This was then laid with ceramic tiles manufactured by Minton and commonly referred to as *encaustic* tiles - ceramic tiles in which the pattern or figure on the surface is not a product of the glaze, but of different colours of clay, often two but up to as many as six colours. A close-up of the 1878 interior view (refer to Figure 11), shows the base of the columns resting on a large block foundation, presumably of concrete. The void between the ground level and top of this block appears to have been filled with the concrete referred to above. The floor levels at the eastern end of the Cathedral were raised above the nave and aisle floor level; two steps up to the choir from the chancel and then six steps from the sanctuary to the altar area (Lyttelton Times, 11 February 1865, page 5). At the east end of the building, in the apse below the floor level, two stone stair cases led down below the floor level into a small basement area containing a passageway and space for the organ blower.

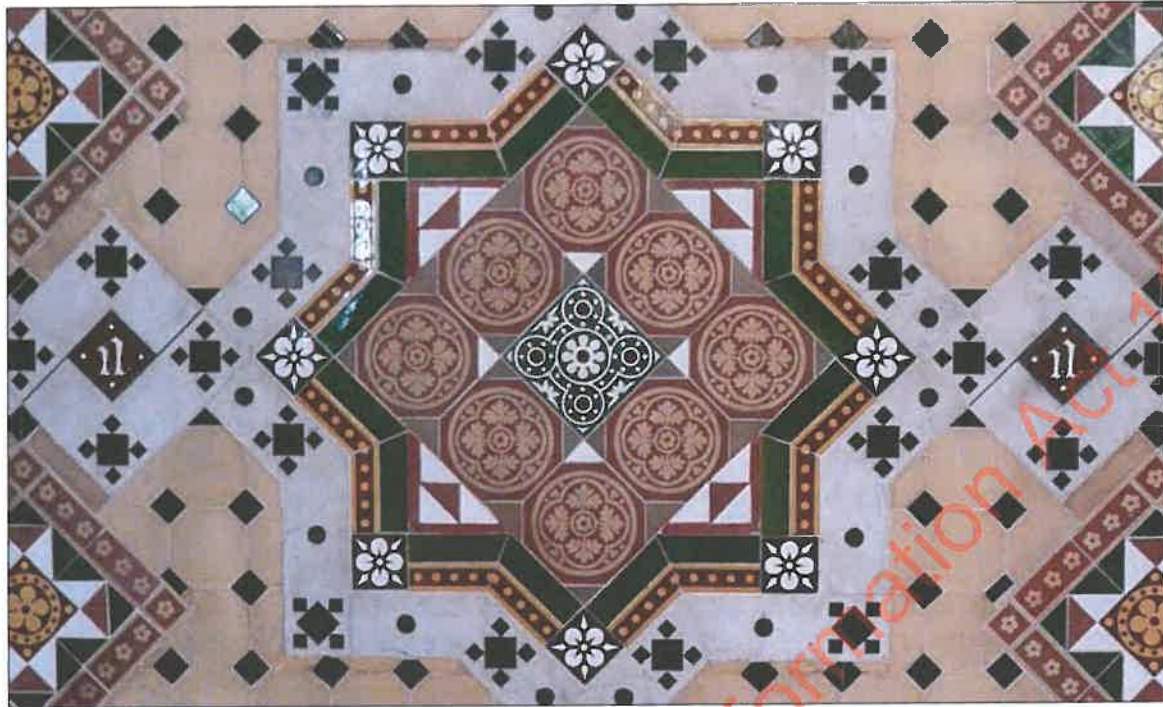
Figure 14: Maw and Co tiles from the Croyke Porch. Image: www.tilesoc.org.uk

The West porch, known as the Croyke Porch was added to the Cathedral building in 1894 and its floor is recorded as being tiled with 'Maw and Co.'s incised tiles, with cement inlays' (Press, 15 June 1894, page 5; Figure 14). Maw & Co were a well-known and successful ceramic tile manufacturer founded in 1850 and based in Broseley, Staffordshire, England. They were known for the quality and highly intricate production of their encaustic tiles and continued manufacturing until c.1970 (Maw's Craft Centre 2016). The porch architect was Benjamin Mountfort and it is possible that he also may have also designed the tiled floor pattern.

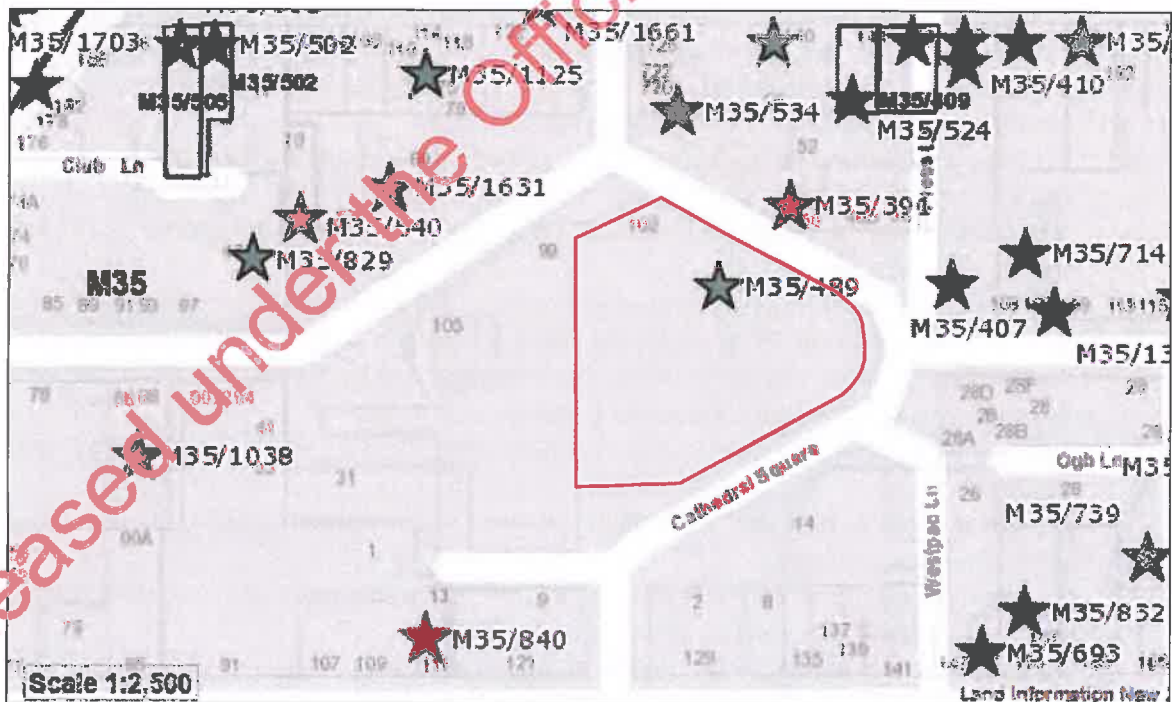
Figure 15: Recorded archaeological sites within the Cathedral assessment area (outlined in red); site M35/489 is located within the assessment area. Source: New Zealand Archaeological Association

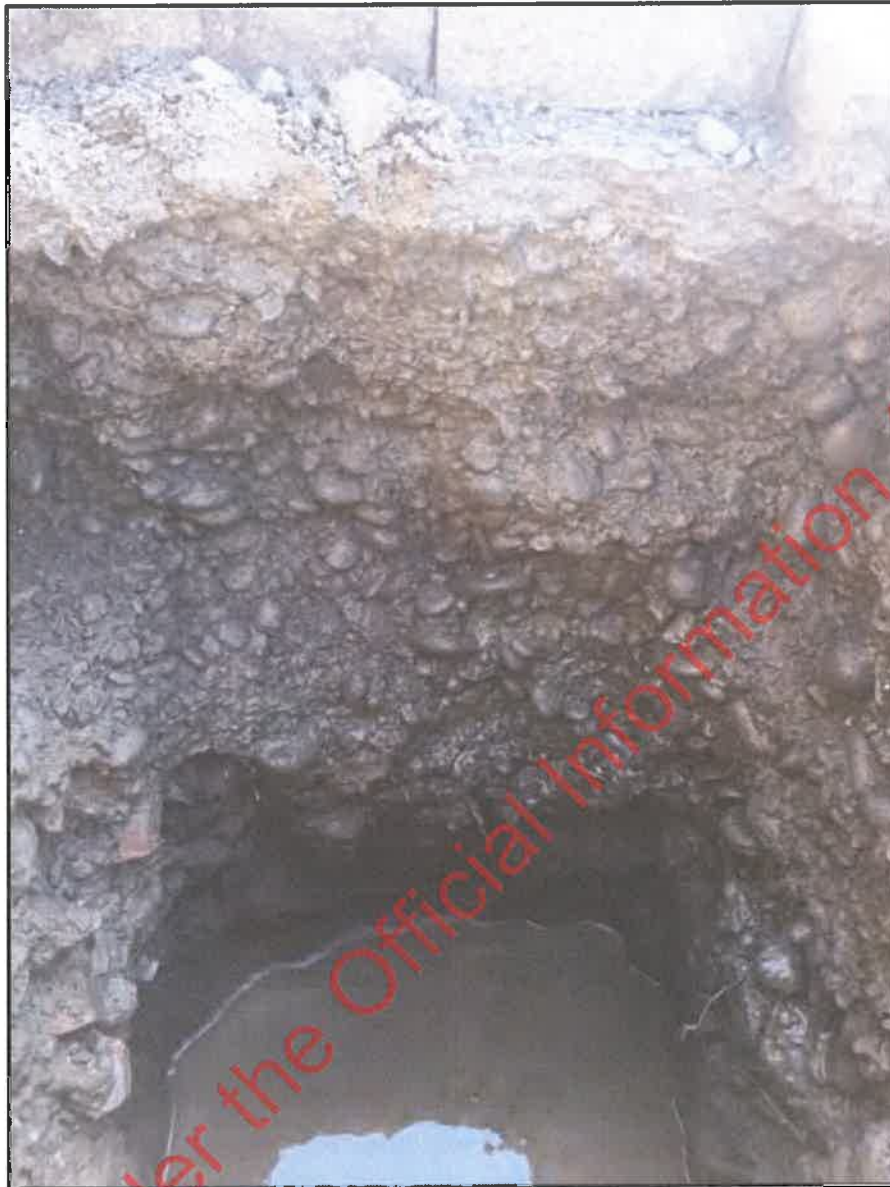
Figure 2. Looking at the northern baulk of the hydro excavated trench at 105 Cathedral Square, Christchurch Central, Christchurch. Image: Ten Anderson 31/08/2016.

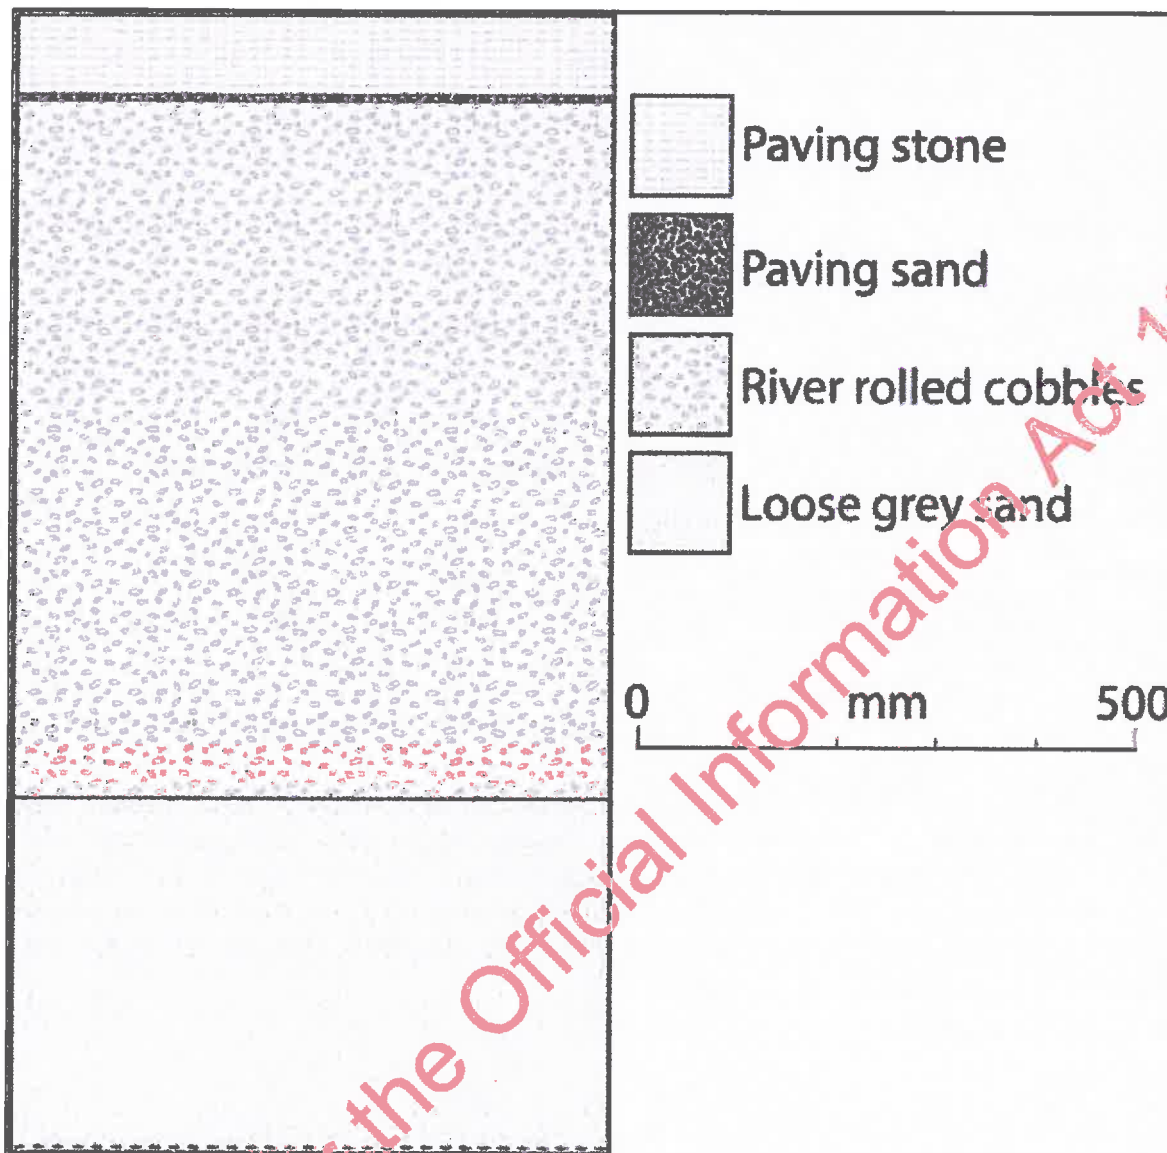
Figure 3. Stratigraphic profile of the northern baulk. Image: Teri Anderson.
