CHRISTCHURCH CATHEDRAL PROPOSED REINSTATEMENT

Heritage Report

Prepared for the Cathedral Working Group

November 2016

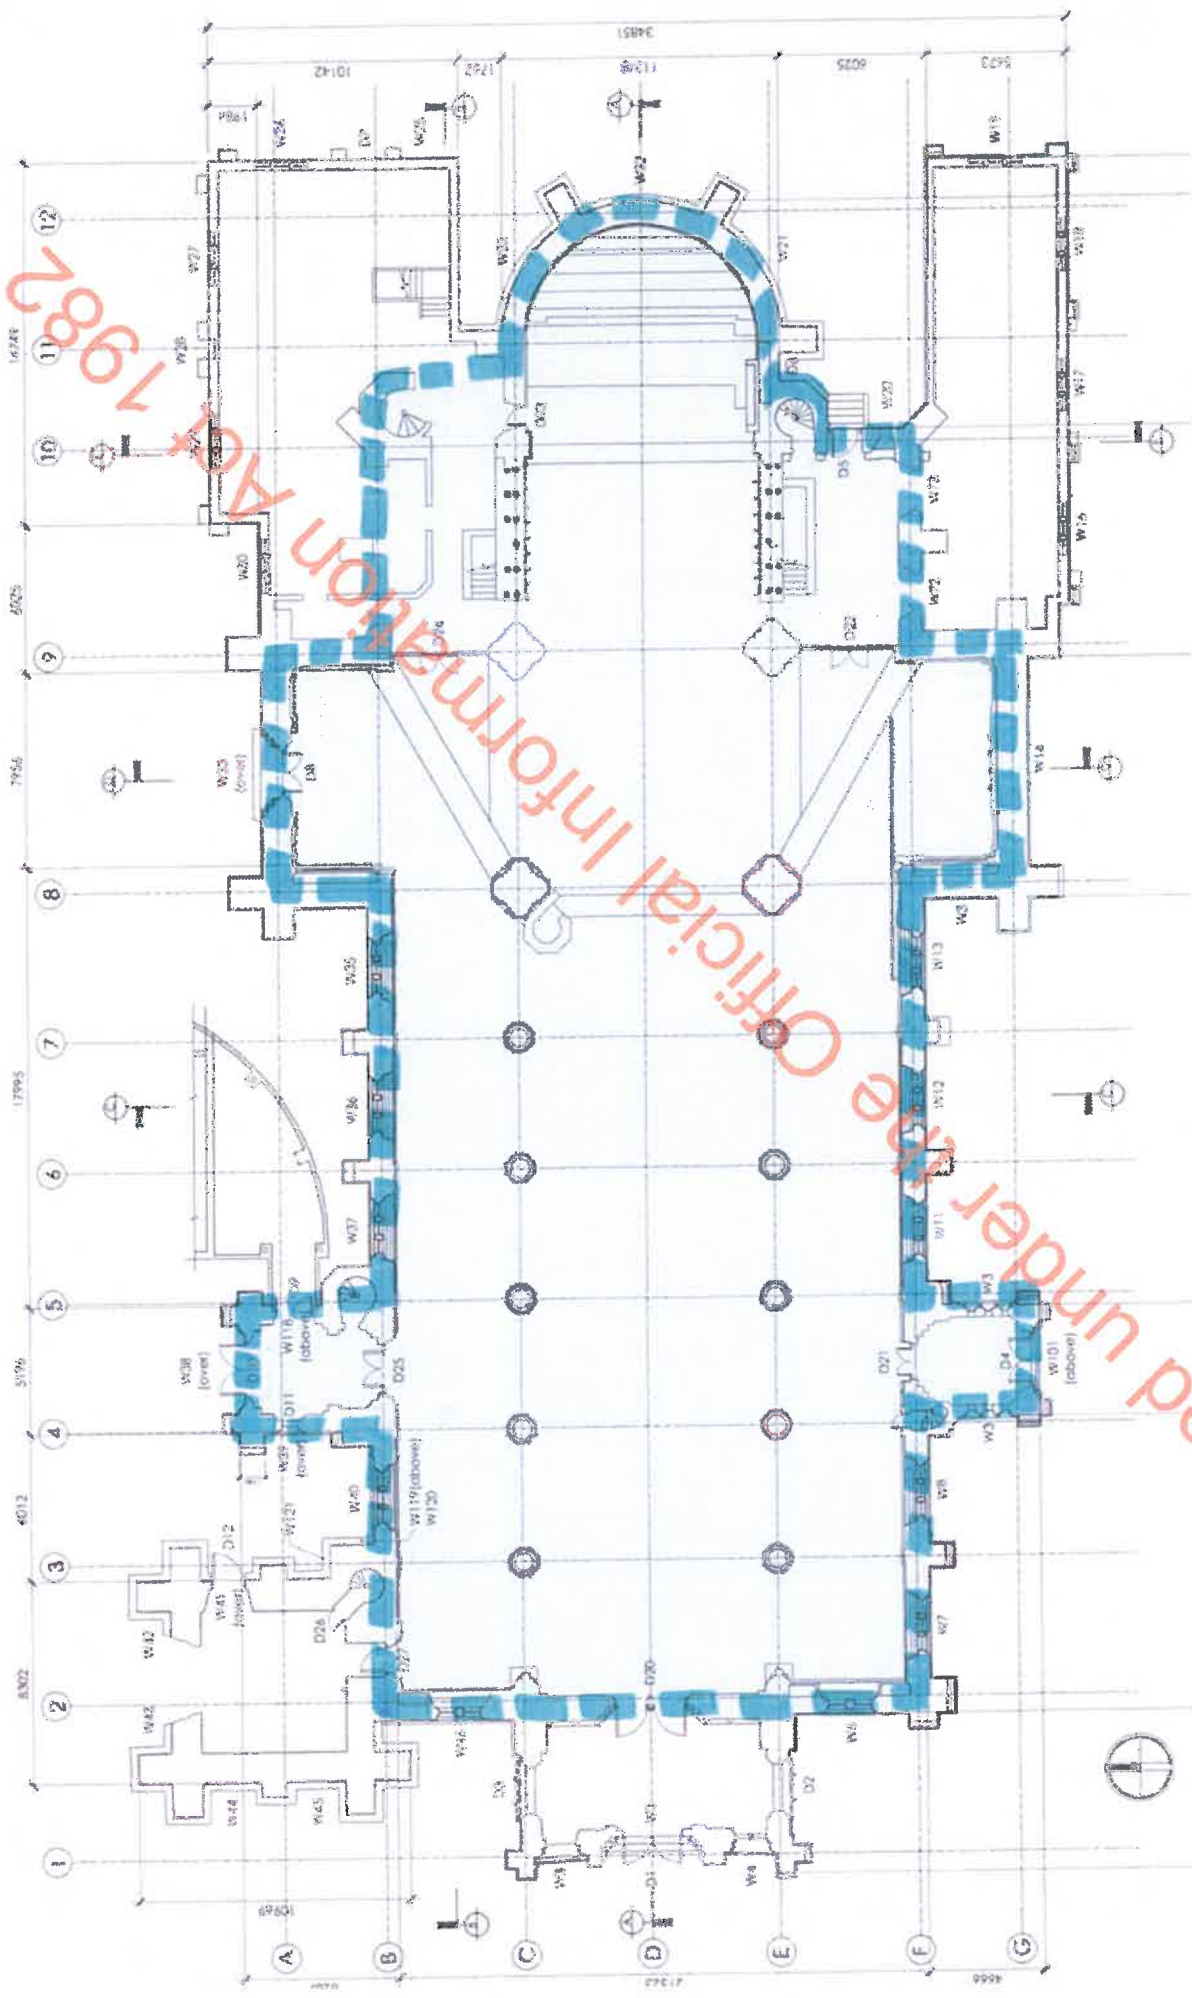
1. Repair in-situ

KEY

- Repair in-situ
- Repair entire roof

Extent of use of each strengthening methodology sketches.

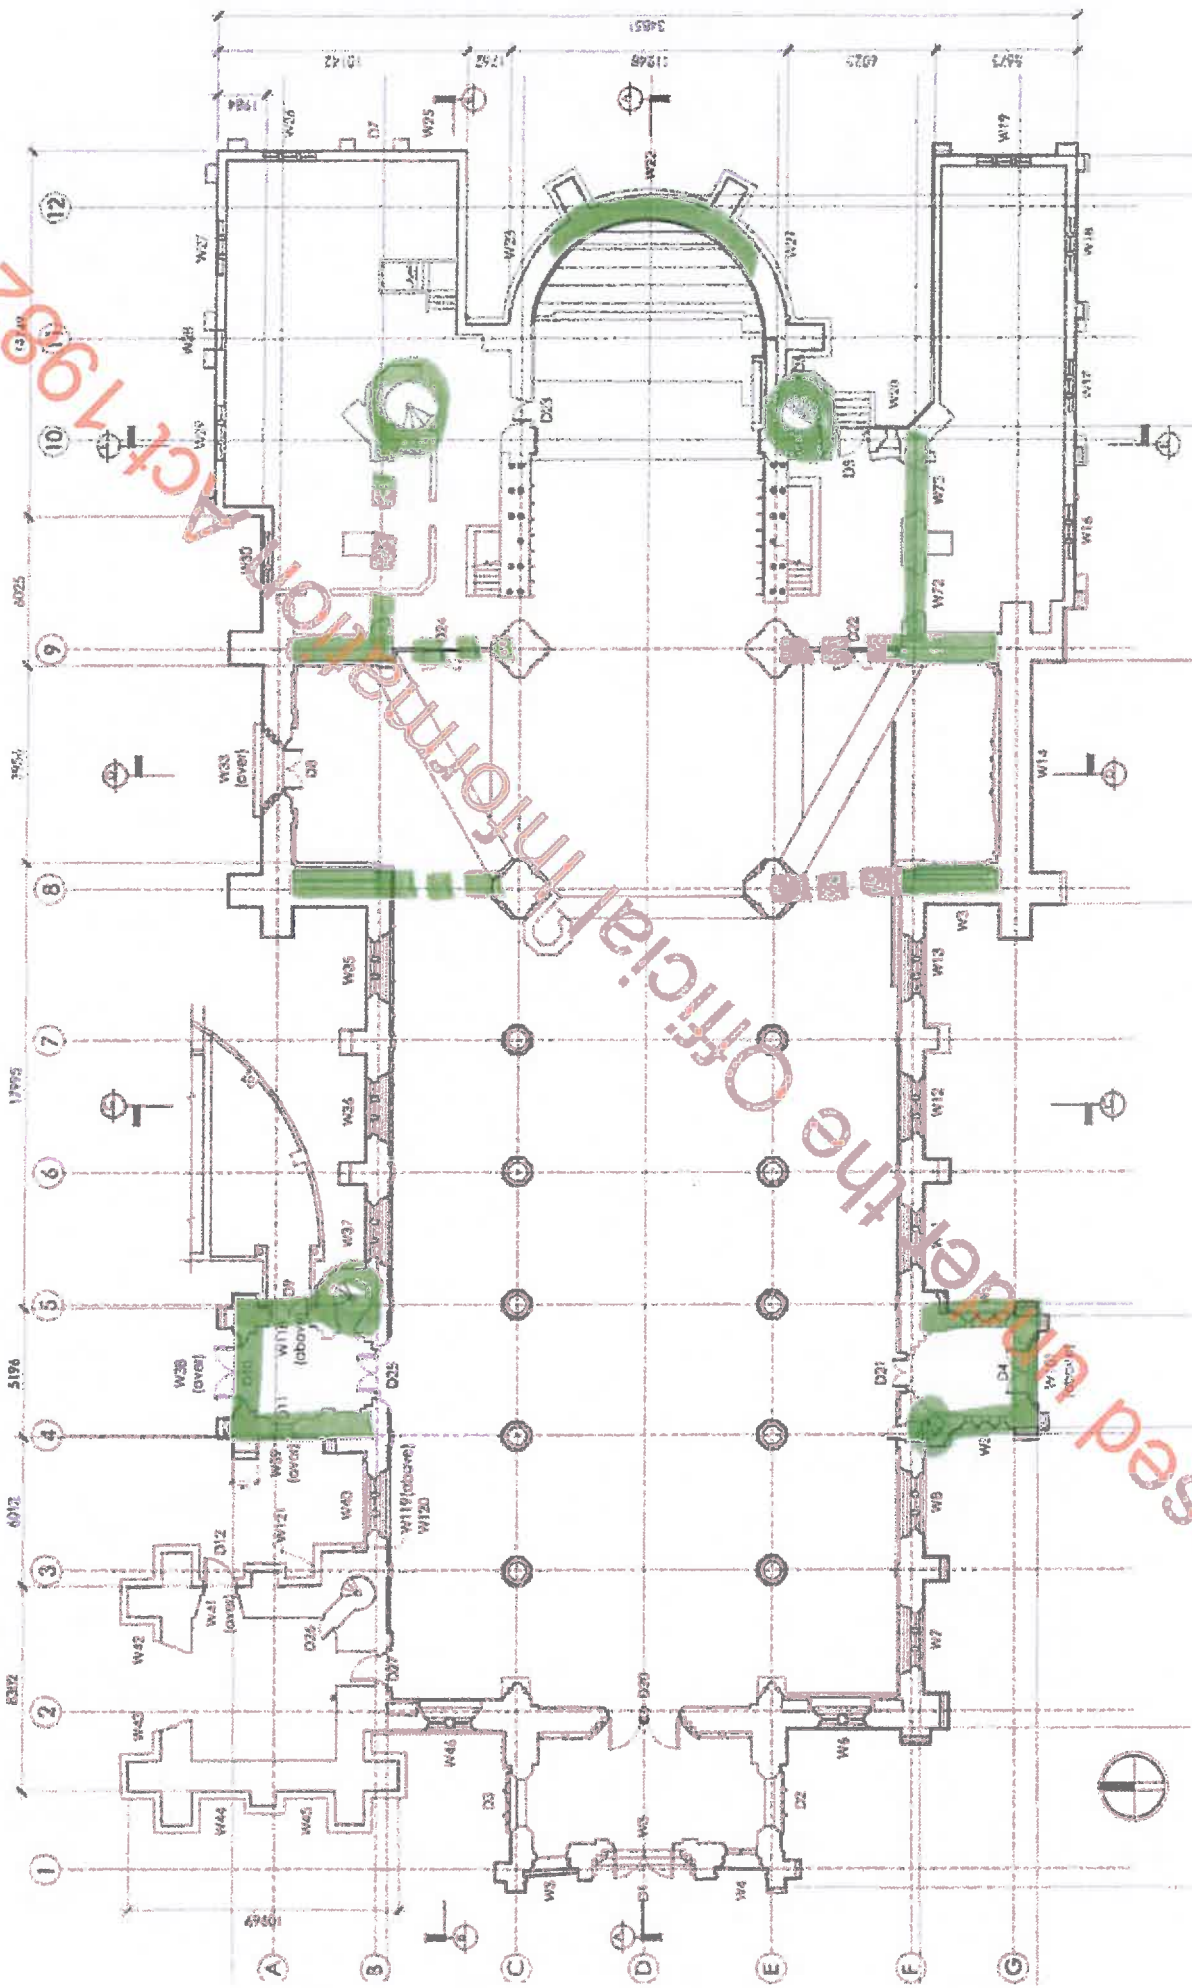
2. Core and drill

KEY
Core and drill

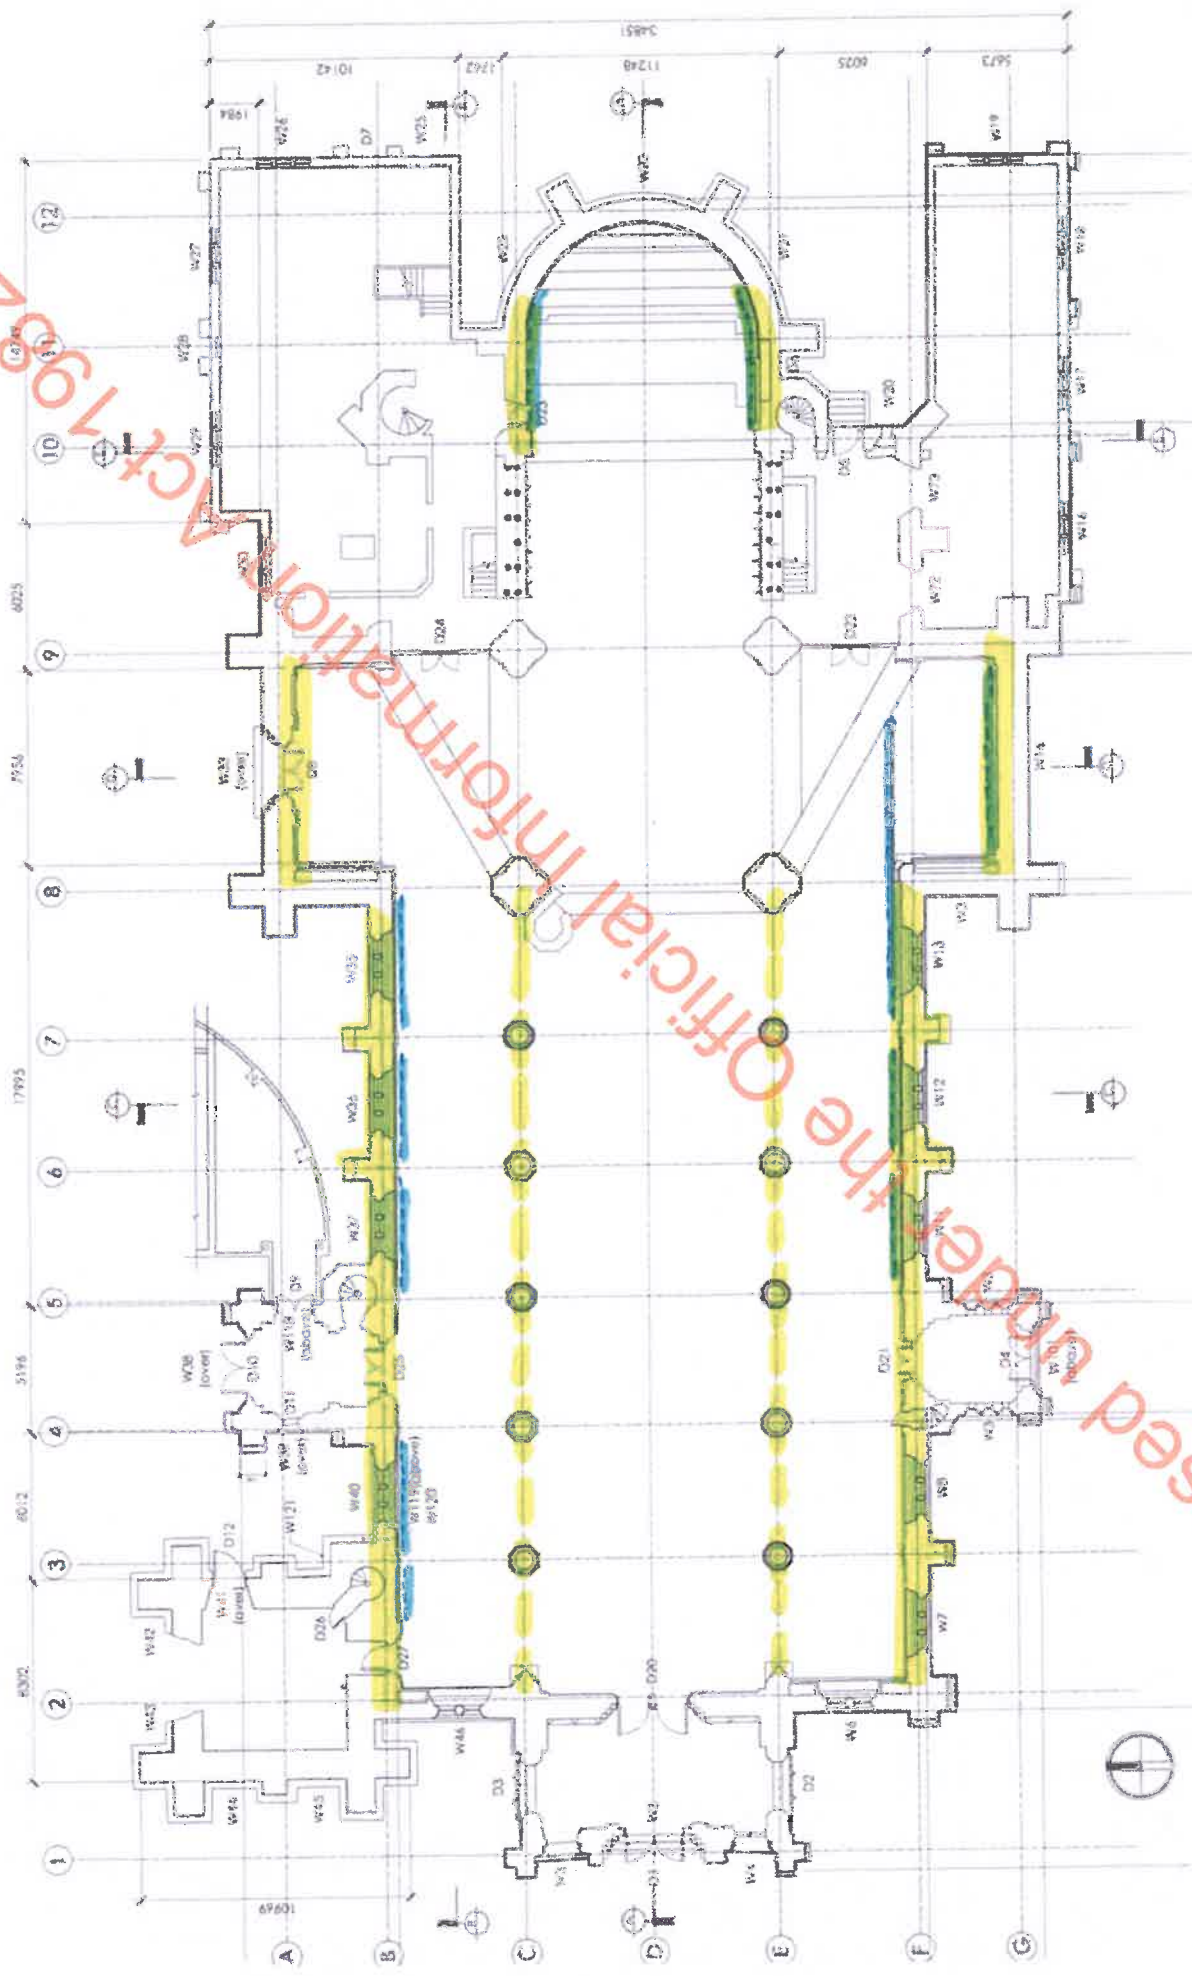
3. Replace core with reinforced concrete
(note non-structural fabric attached to existing walls)

| HCG Reference | HCG proposals | Heritage Fabric Affected | Non-structural heritage fabric affected | How affected | Mitigation |
|---|---|--|---|---|--|
| 6.4.10 | Replace north and south aisle buttresses in reinforced concrete and replace exterior stone as veneer. | Halswell stone faced buttresses with rubble core and limestone ashlar inner wythe. | | Masonry deconstructed to ground level, exterior stone labelled and stored for refixing onto concrete core. Rubble core and internal ashlar removed. | |

| HCG Reference | HCG proposals | Heritage Fabric Affected | Non-structural heritage fabric affected | How affected | Mitigation |
|---|---|--|---|--|--|
| 6.4.12 | Upper clerestorey walls. | Halswell stone exterior wythe with rubble core and limestone ashlar inner wythe. | Carved decorative string courses etc. | Rubble core grouted, cut back, new concrete wall and inner wythe replaced. | |

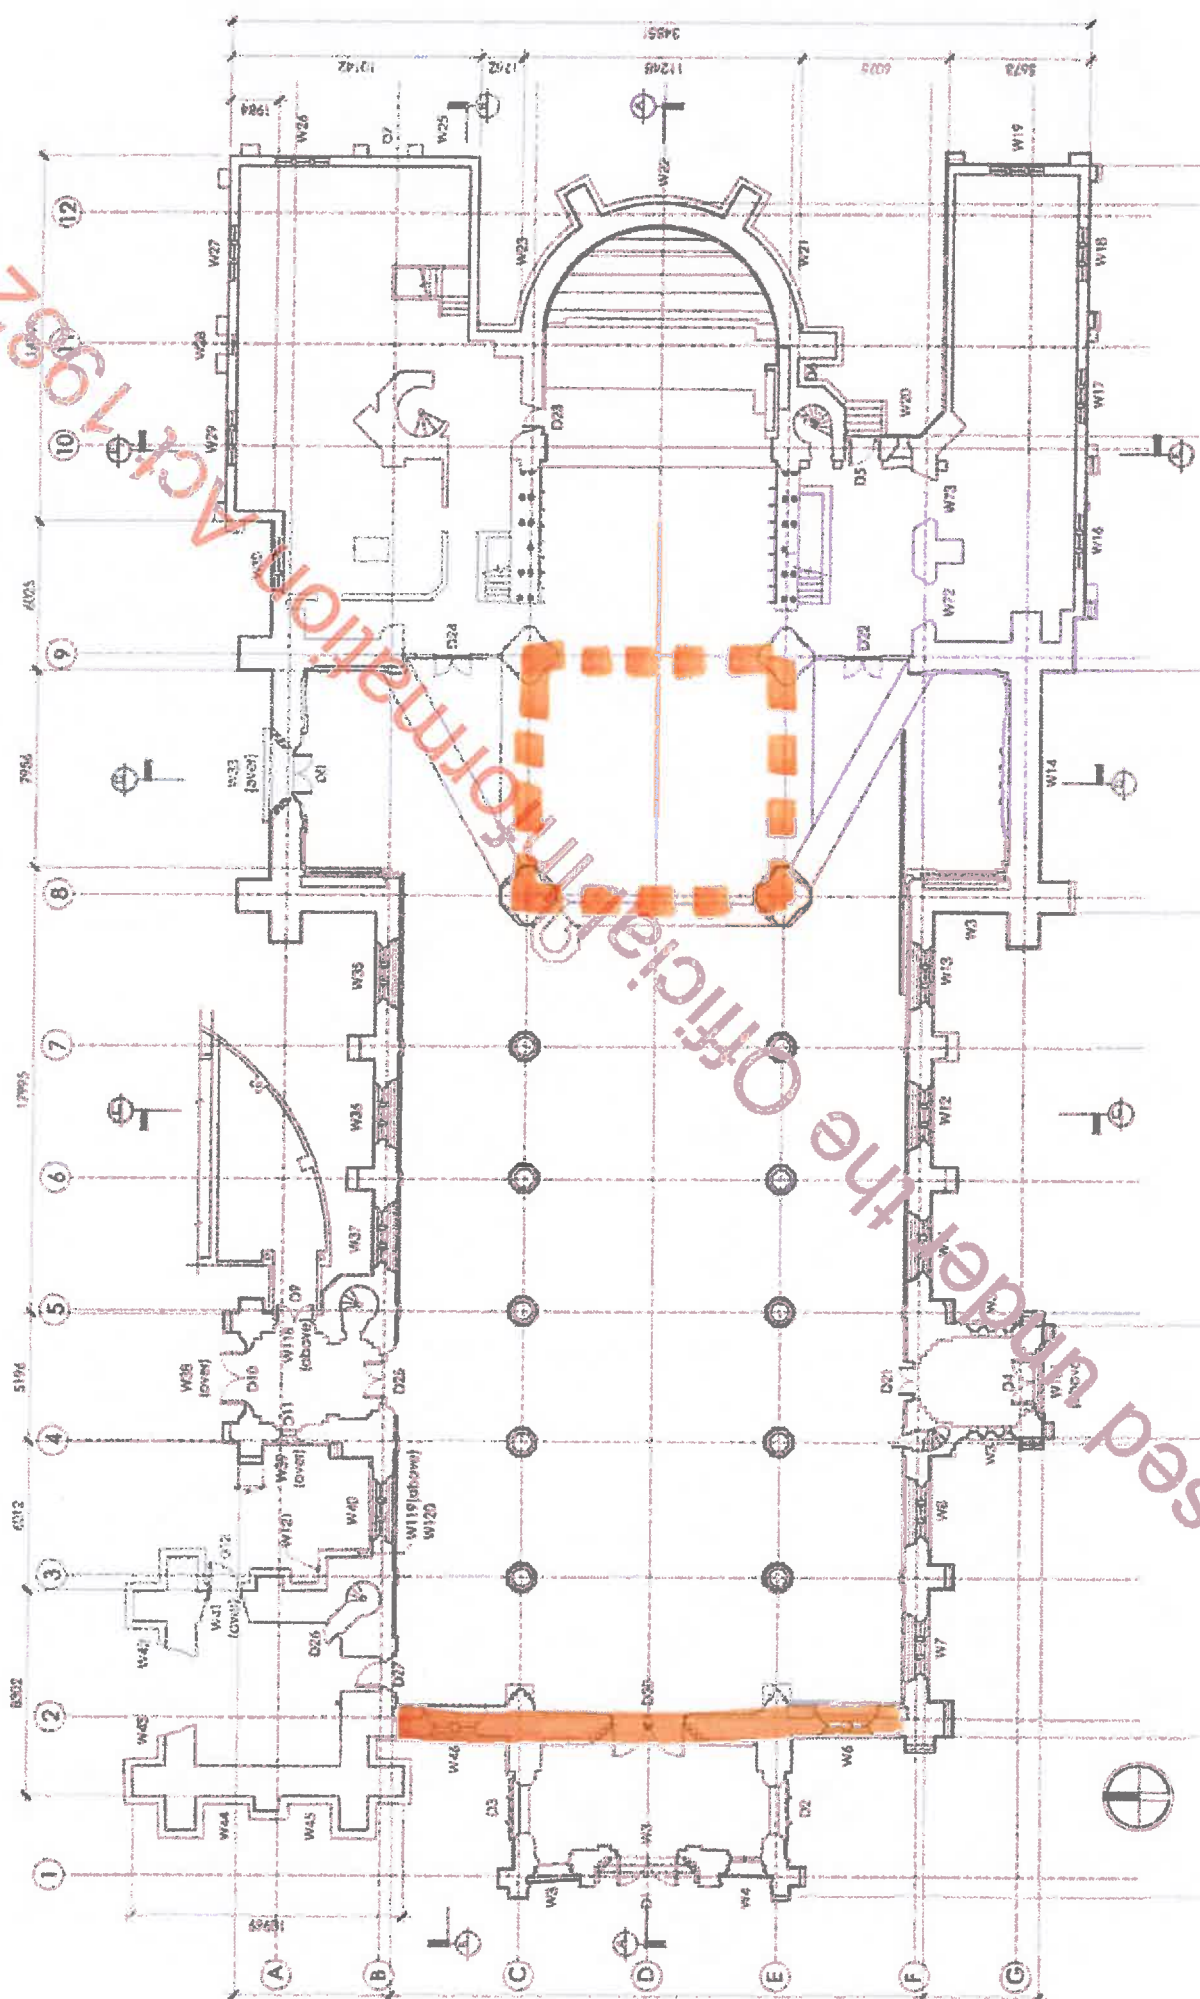
4. New structural steel frames

KEY

New structural steel frame
